# Structural Condition Assessment

## Former Schatz Manufacturing Co. Building Campus

Fairview Avenue, Poughkeepsie NY

Date: June 28th, 2024

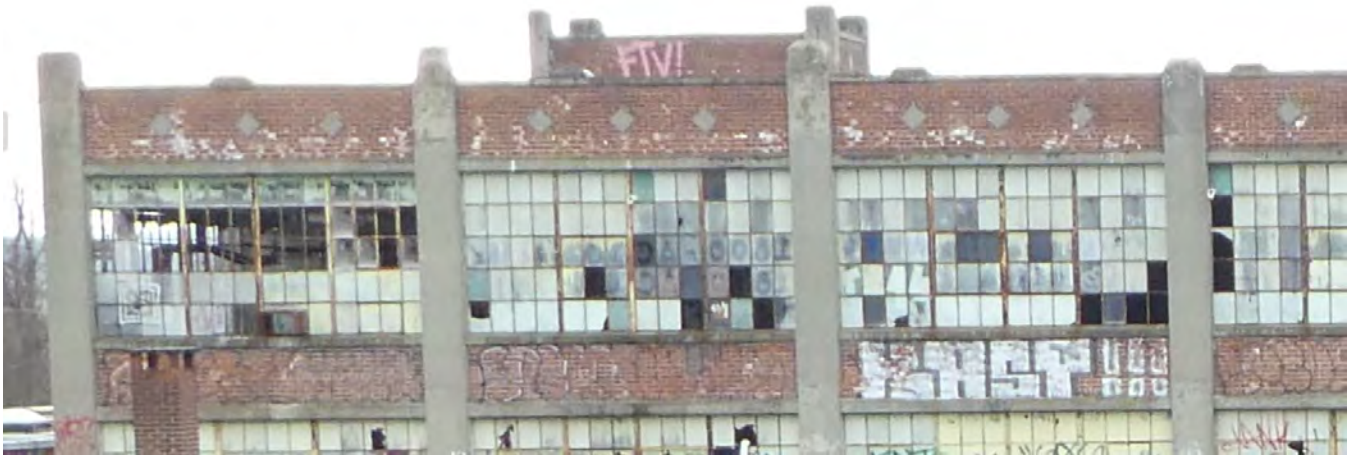
- Exterior Concrete Elements (columns, column capitals, concrete beams, etc.) exhibit varying levels of deterioration. Cracking, staining, and spalling of structural elements were observed on interior and exterior faces of the concrete members. Concrete members along the roof level of the buildings exhibit the most severe deterioration.

*Photo 24: South elevation of Building 1. Deteriorated concrete lintels, columns, column capitals and parapet copings.*

- 1.1.11 The concrete lintels and sills enveloping Building 1's exterior should be repaired. This is particularly evident along the north face and wall faces that are above the lower roof and are exposed to freeze and thaw cycles.

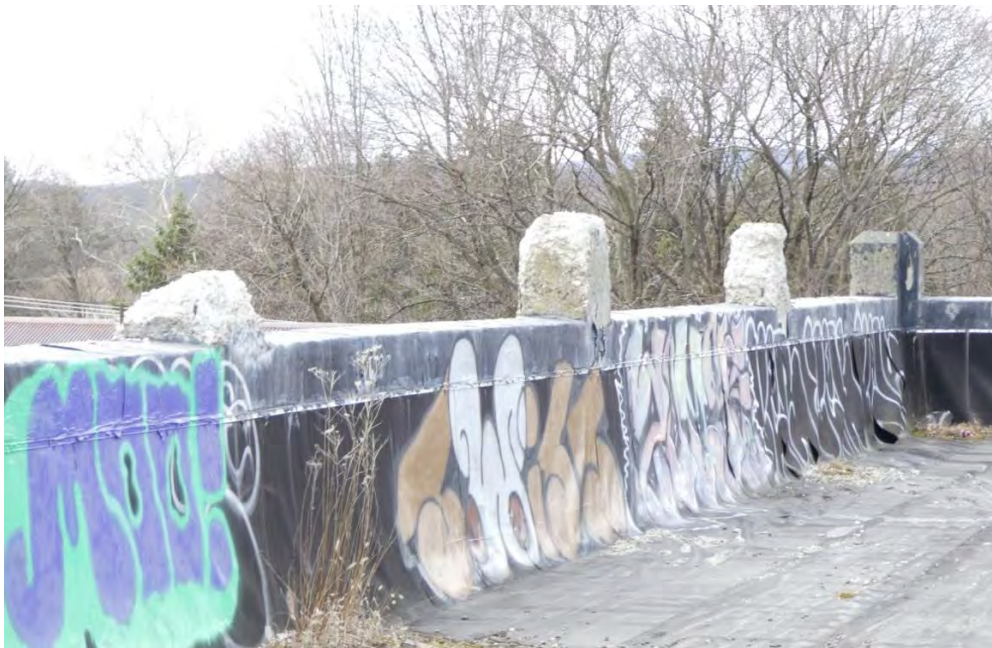
*Photo 25: Building 1 South parapet wall; deteriorated column capitals.*

- 1.1.7 There are several concrete column caps on top of the exterior masonry columns on Building 1 that are in poor condition and should be removed or replaced.
- 1.1.8 The concrete stair landing and concrete landing beam in Building 1 south stair should be repaired.
- 1.1.9 All the concrete slabs at Building 1 exhibit a concerning level of cracks, calcified stalactites along the bottoms of the slab, staining, and organic growth. These are all likely caused by repeated water infiltration into the building. Replacement of the roofing system and proper flashings should help with restricting the

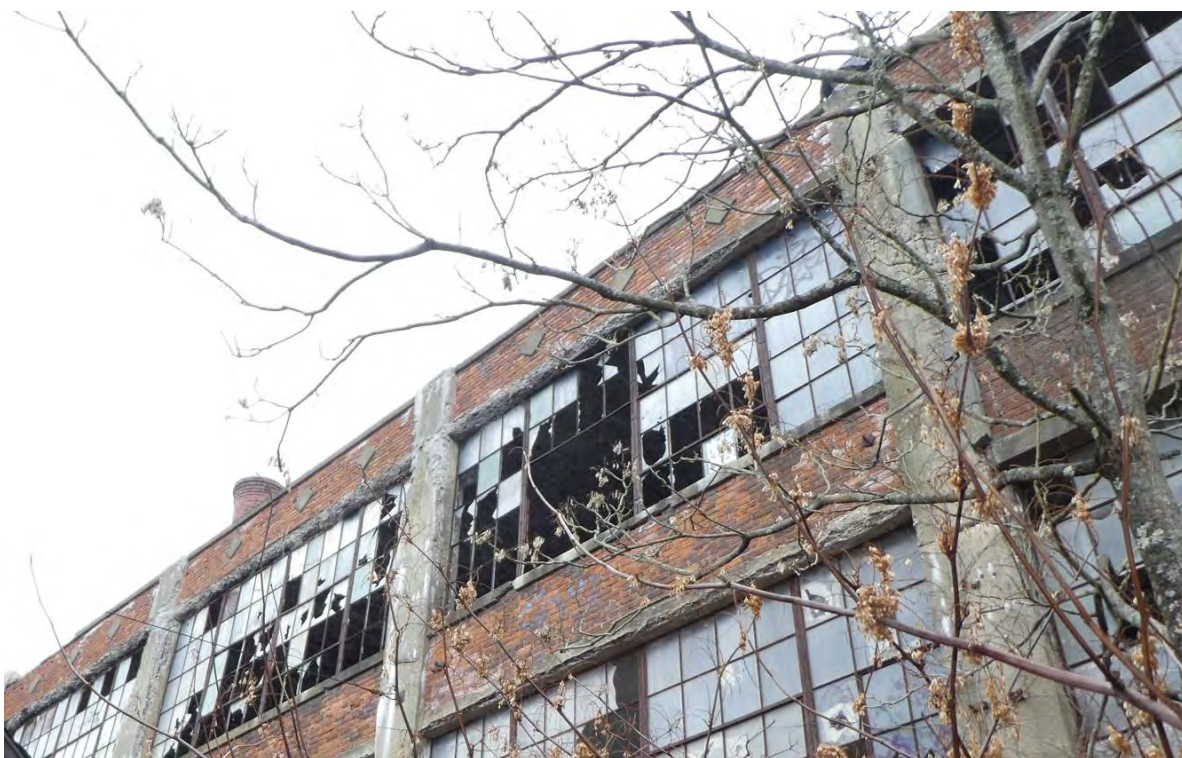
*Photo 26: North Elevation Building 10, Third Floor. Deteriorated concrete columns, lintels, copings.*

- 1.2.7 The concrete lintel supports along the exterior faces of Building 10, 12, 13 and 14 are in unsafe condition and should be repaired immediately.

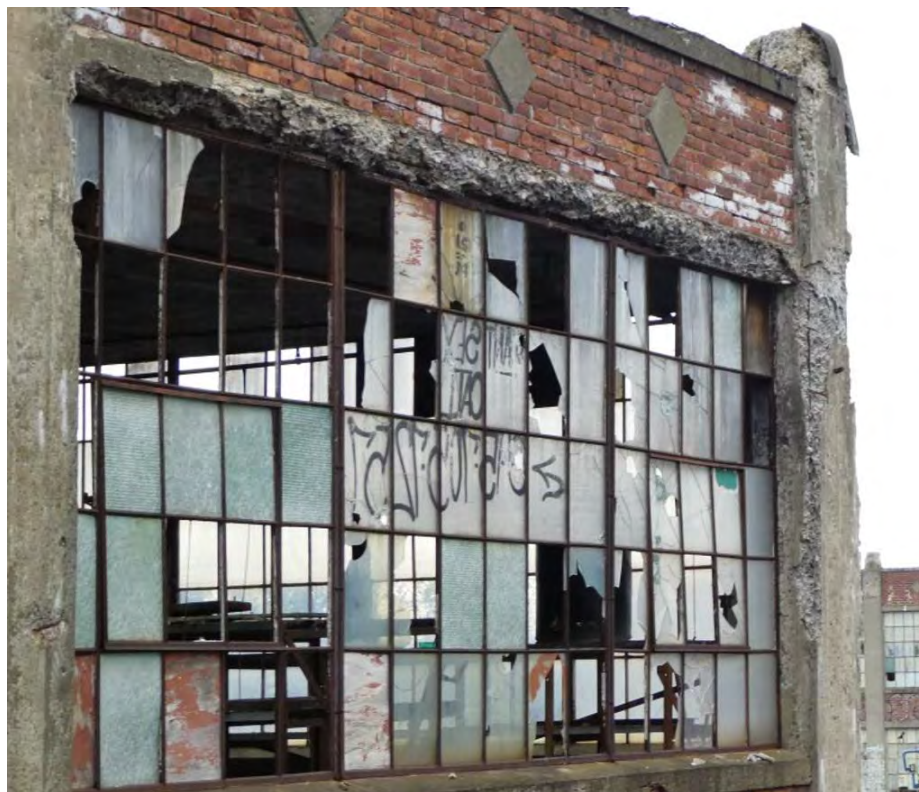
*Photo 27: East Elevation Building 10, Third Floor. Deteriorated concrete columns, lintels, copings.*

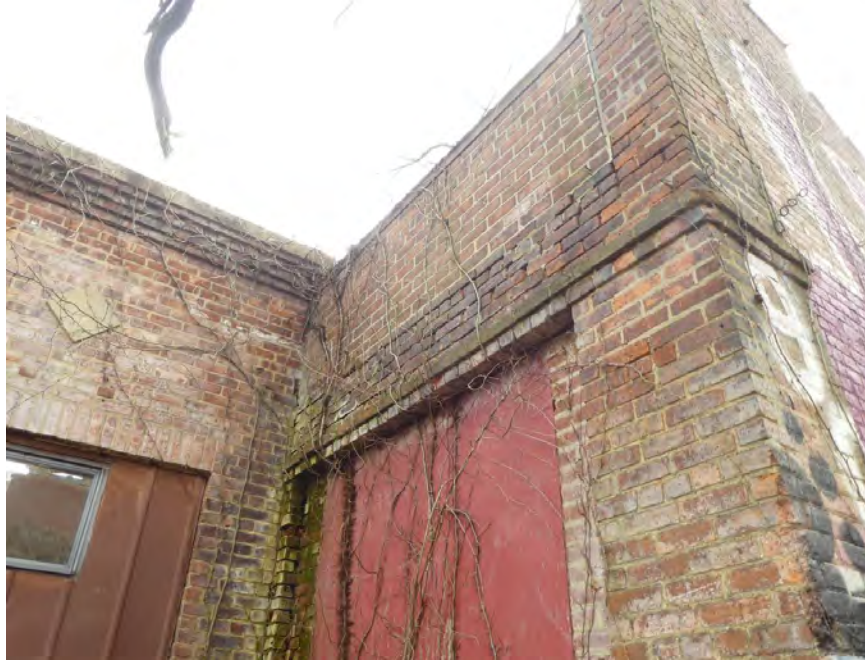
- Staining along the interior and exterior faces of most walls were observed. Sources of staining consist mostly of graffiti and organics (algae, vines, etc.). Along the exterior faces of the brick masonry walls, efflorescence (white residue formed from soluble salts) was observed primarily along the roof parapet level and 2<sup>nd</sup> floor levels, with some instances along the first floor.

*Photo 28: North Elevation Building 9. Typical occurrence of organic staining (algae, vines) and graffiti.*

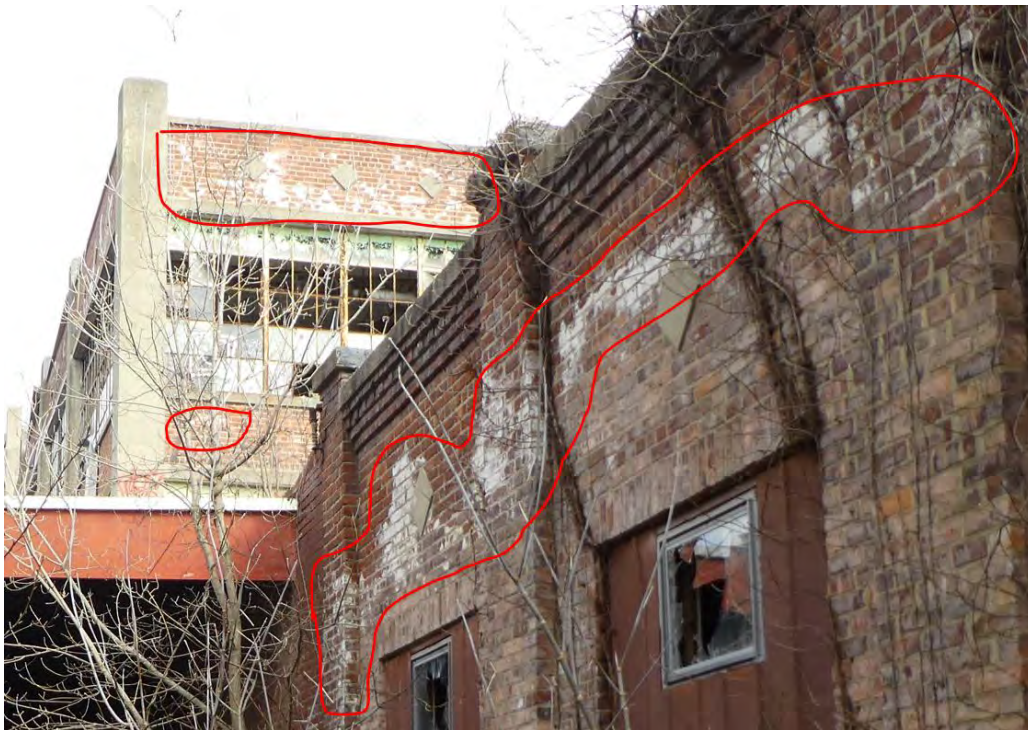
*Photo 29: South Elevation Building 1/West Elevation Building 2. Typical occurrence of efflorescence in masonry walls.*

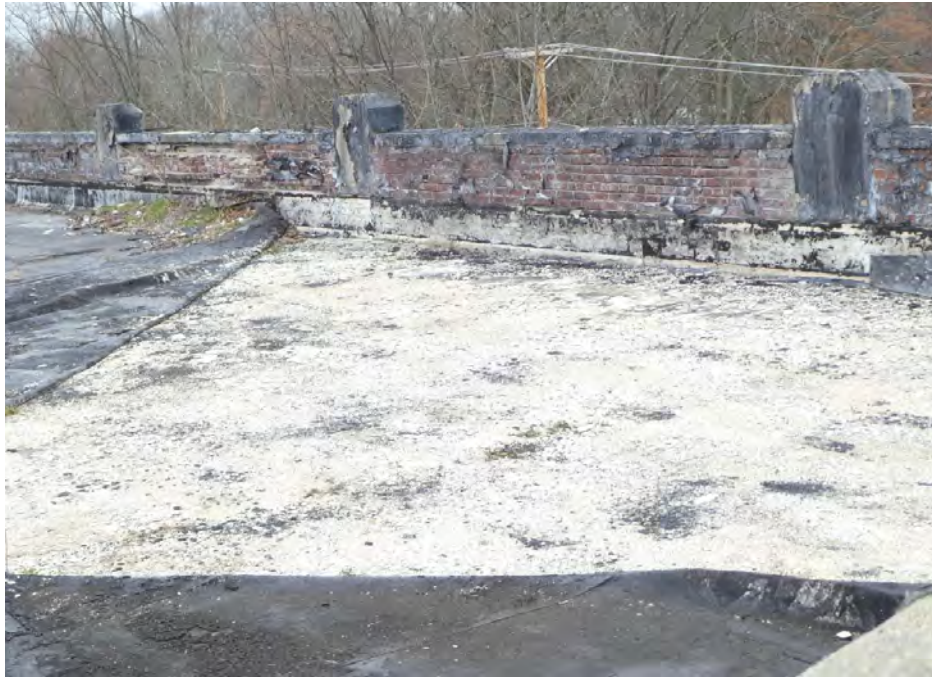
- Although not structural, majority of the roofs observed exhibit some form of failure. The existing membrane roofs on majority of the buildings have open seams, have blown off portions of the roof, have flashing failures where terminated at parapets, and failures along through-wall flashings between coping stones and parapets. All locations of failed roofing are sources of moisture which directly and indirectly impacts structural elements.

*Photo 30: Building 14, existing membrane roof pulled from roof deck and parapet.*

- 1.2.12 The roofing material, although not structural, is beyond its service life and all roofs should be replaced as soon as possible to prevent the continued infiltration of water into the building enclosure.

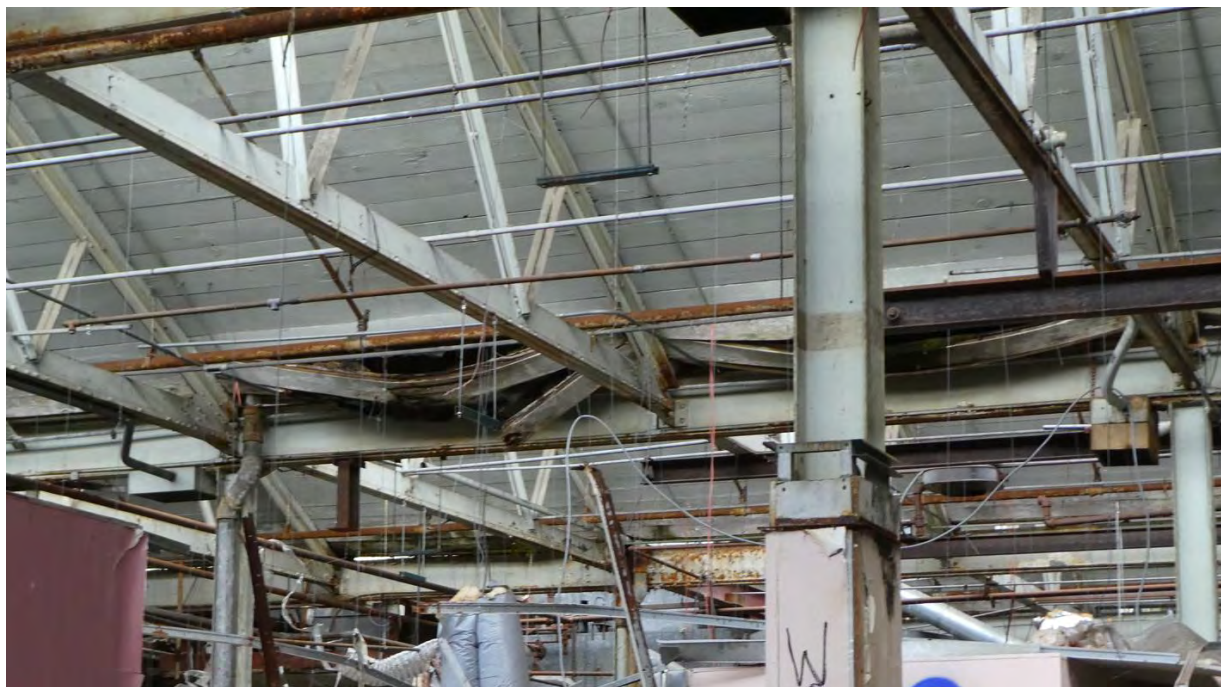
- There are structural roof deck failures along several of the buildings, likely due to moisture infiltration through the failed roofing. The following buildings were observed to have structural roof deck failures:
  - Building 2 (metal edged gypsum plank).
  - Building 3 (metal edged gypsum plank).
  - Building 4 flat roofs and sawtooth valleys (wood tongue-and-groove plank).
  - Building 5 sawtooth valleys and portion of collapsed roof (wood tongue-and-groove plank).
  - Building 6 (poured gypsum deck on steel bulb tees).
  - Building 7 (wood tongue-and-groove plank).
  - Building 8 sawtooth valleys (wood tongue-and-groove plank).
  - Building 21 (metal edged gypsum plank).

*Photo 34: Building 4, wood plank deck failure.*

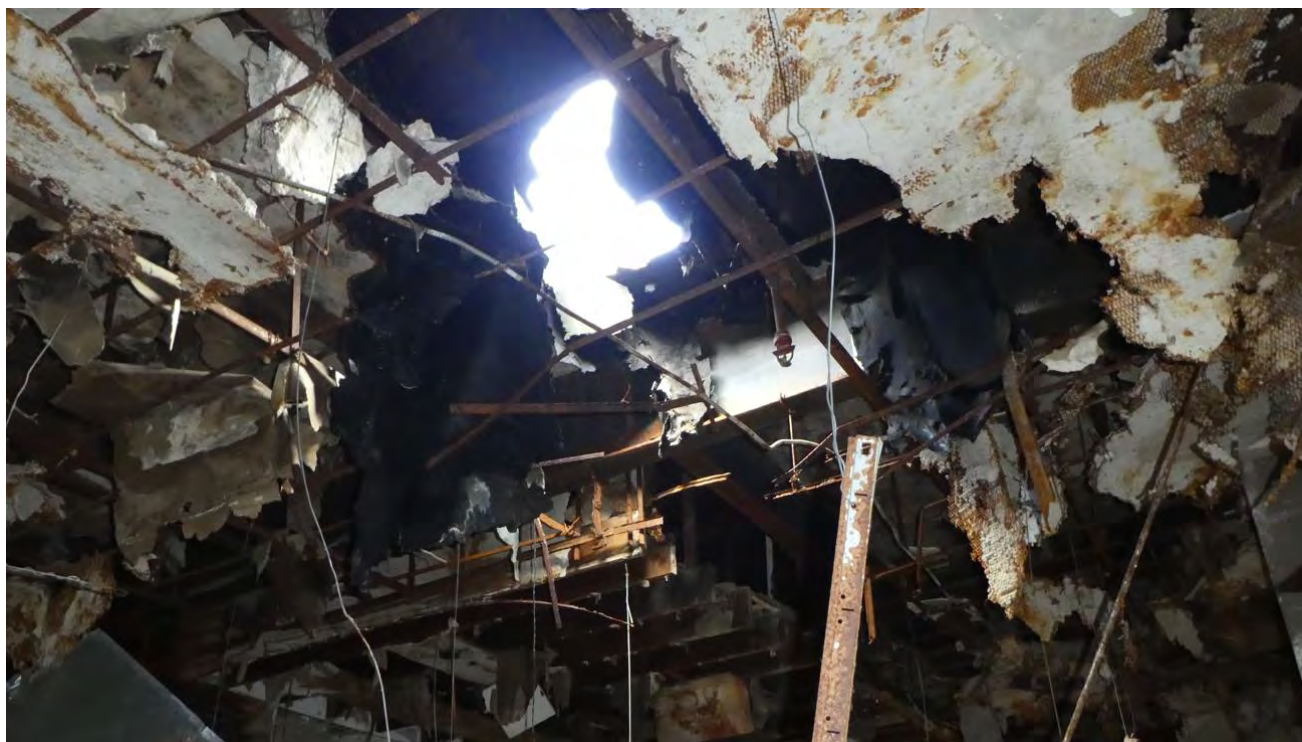
*Photo 36: Building 6, poured gypsum deck failure.*

- 1.1.1 Building 6 is in unsafe condition due to the failure of the poured gypsum roof and the southern entry canopy, as well as the extent of deterioration of the floor. Building 6 should be demolished.

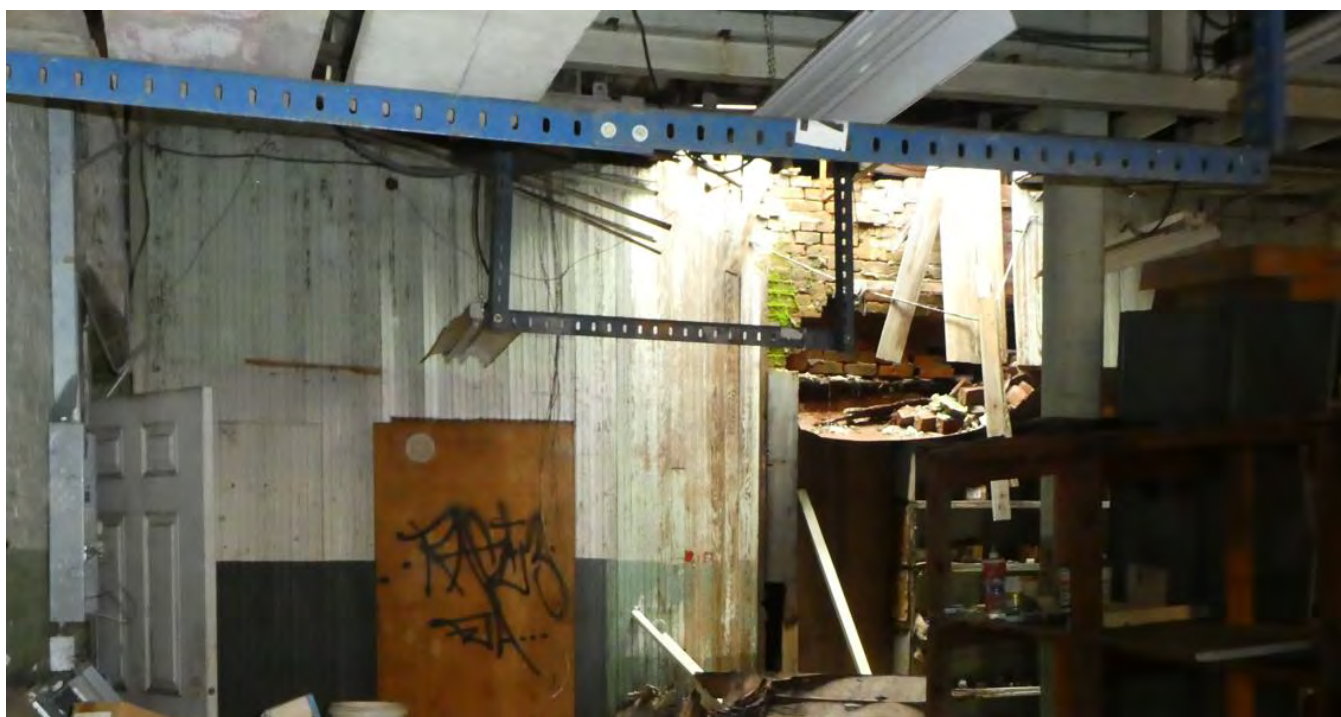
*Photo 37: Building 7, wood plank deck failure.*

- 1.1.2 Building 7 is in unsafe condition due to the failure of the wood framed floor and roof and the extent of masonry deterioration. Building 7 should be demolished.

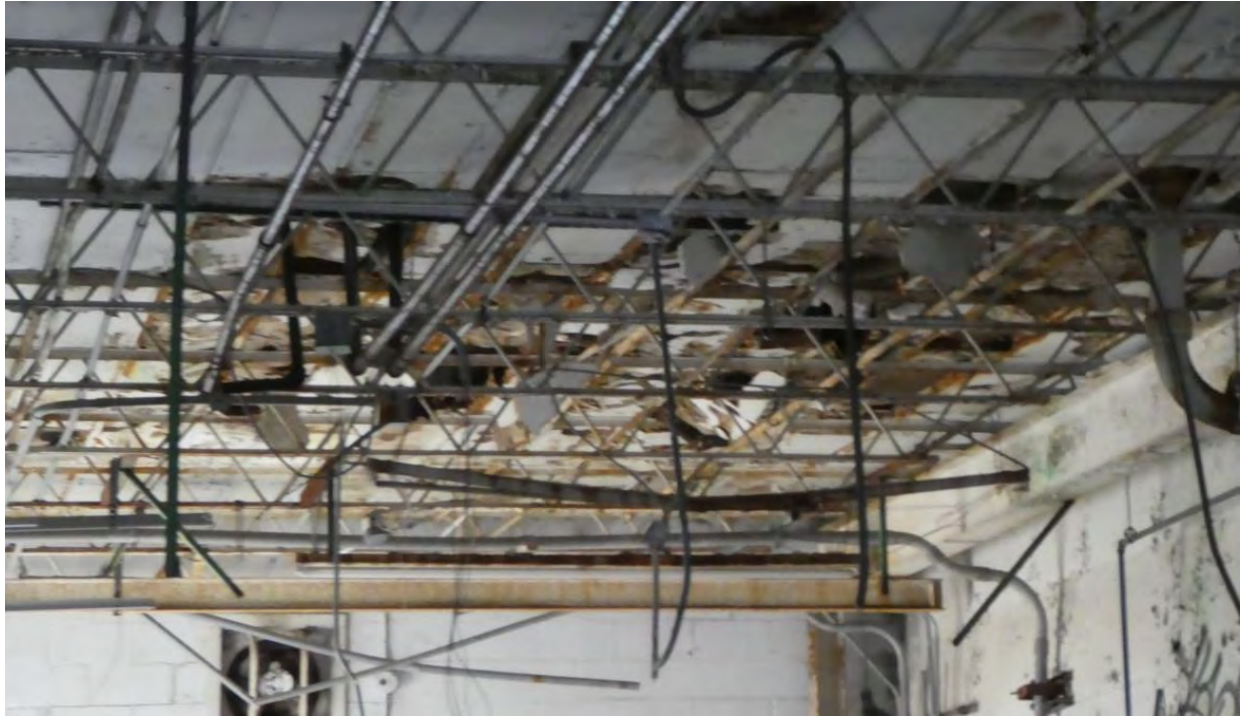
*Photo 38: Building 21, gypsum plank deck failure.*

- 1.2.11 Based on the extent of roof structural deterioration and/or failure, the metal edged gypsum plank roof deck on Building 21 should be removed and replaced as soon as possible to prevent further failure.

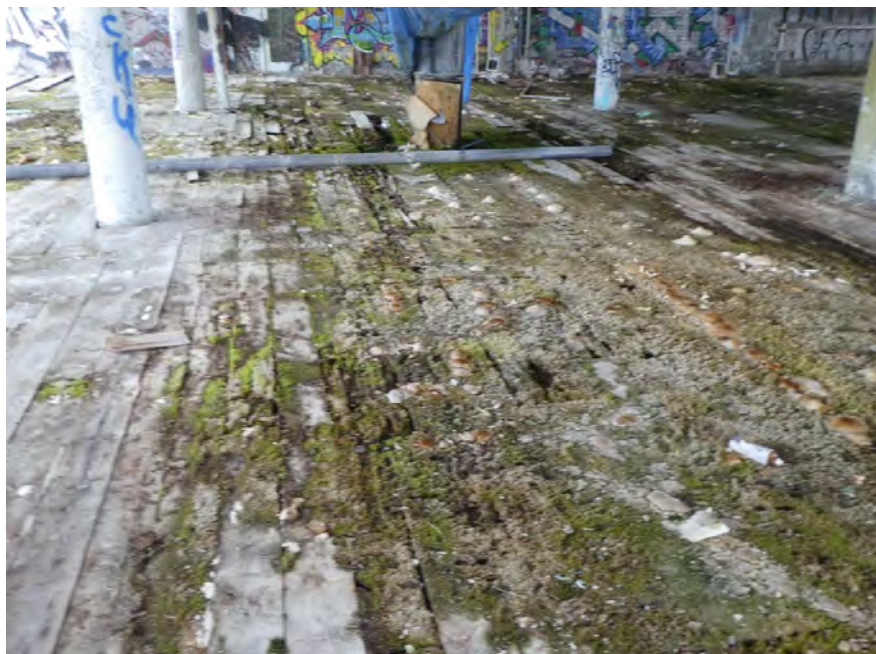
- The buildings consisting of cast-in-place concrete floor slabs and concrete columns contain wood flooring, which is saturated with moisture and organic material, likely from moisture infiltration from the roof (photo 39). This moisture is trapped within the wood flooring and is permeating down into the lower floor levels, which can be seen by the numerous calthemite straw stalactites (photo 40) observed from the ceilings. Additionally, mineral deposits can be seen permeating through the column/slab interface (photo 41).

*Photo 39: Typical concrete deck with wood plank flooring; organic growth.*

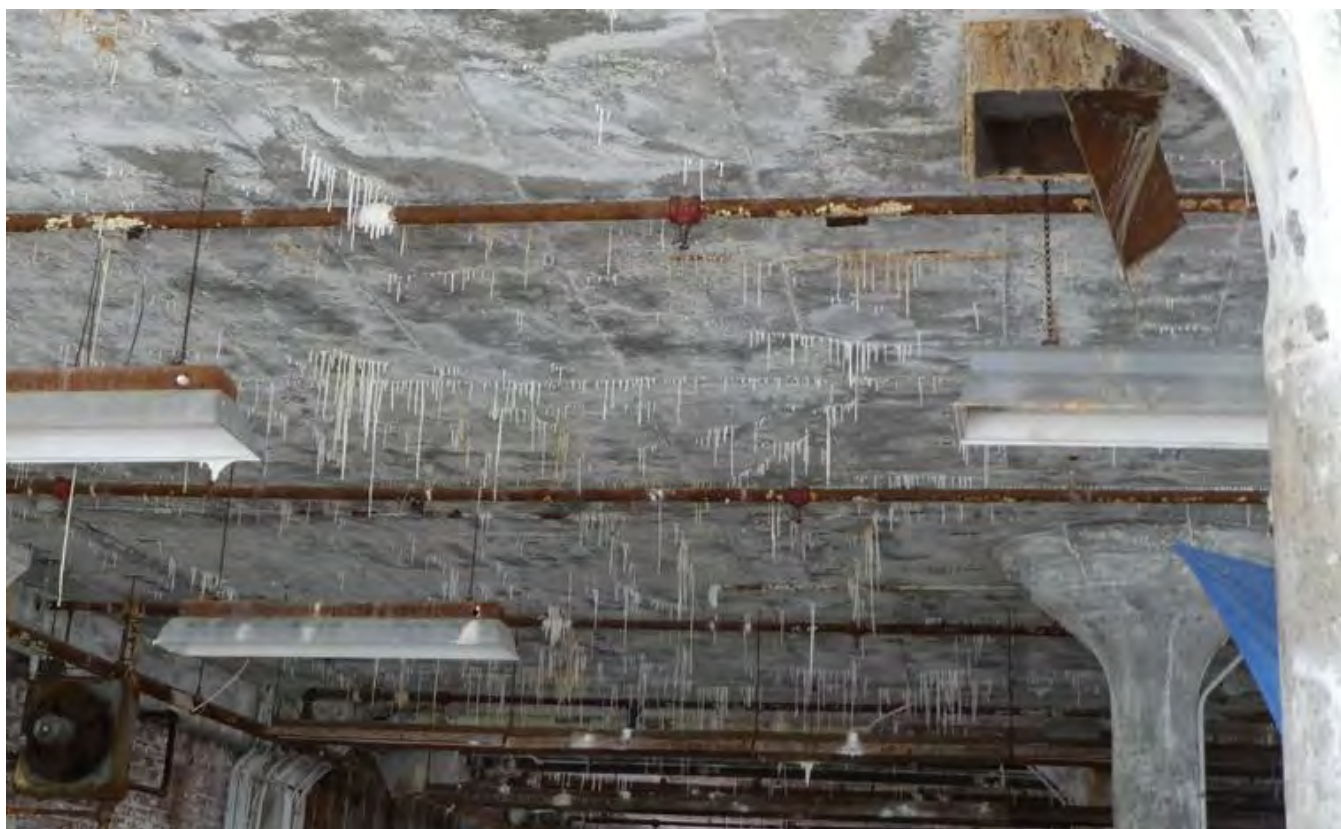
*Photo 40: Typical concrete deck with calthemite straw stalactites along ceilings.*

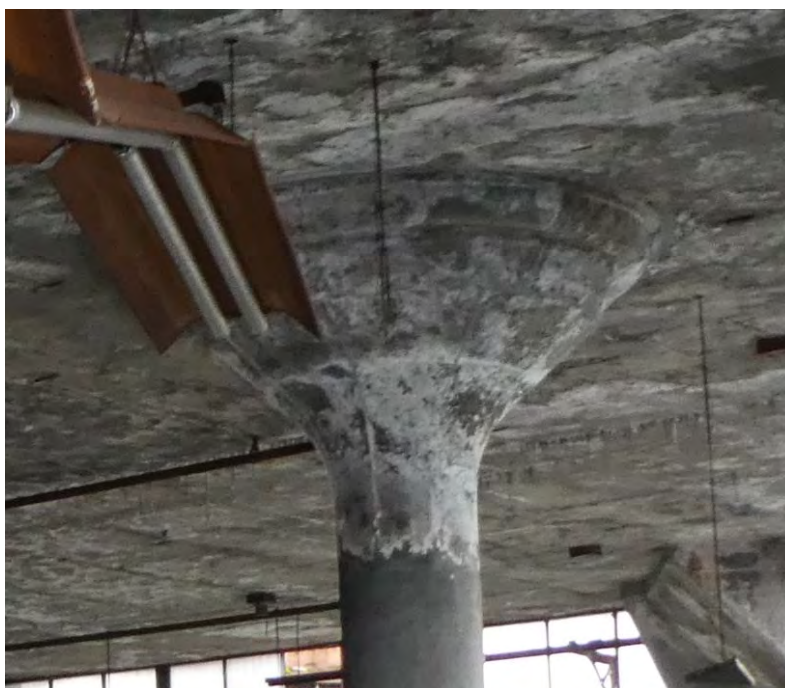
*Photo 41: Typical concrete deck with calthemite straw stalactites along ceilings.*

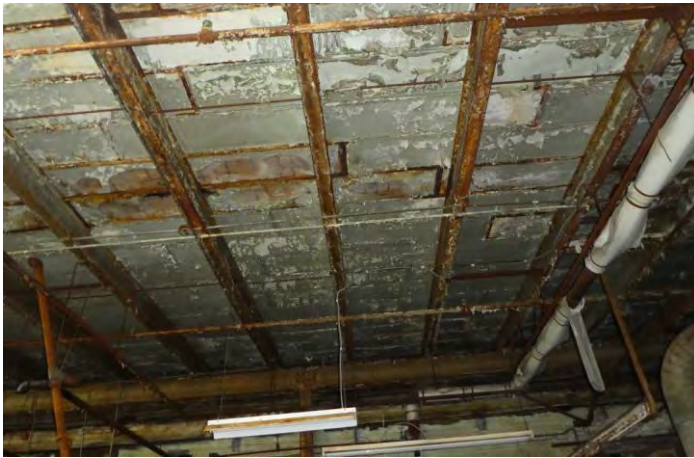
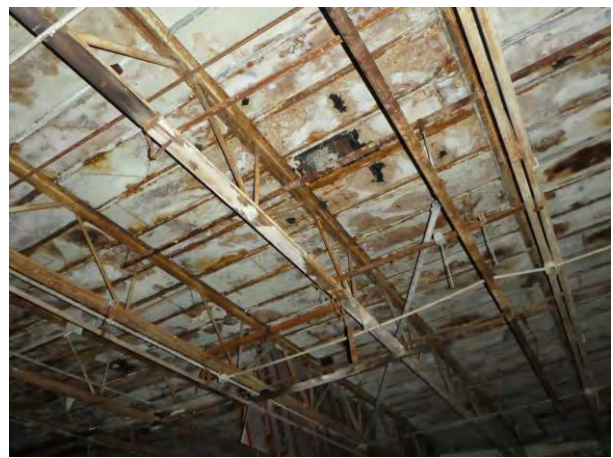
- Structural steel elements (joists, spandrels, girders, columns) supporting the various roofs within the buildings exhibit varying levels of corrosion, likely due to the infiltration of moisture from various points of entry (roof, wall fenestrations, etc.).

*Photo 42 (left): Typical structural steel spandrel beam corrosion (Building 8); Photo 43 (right): Typical open web metal joist corrosion (Building 21).*

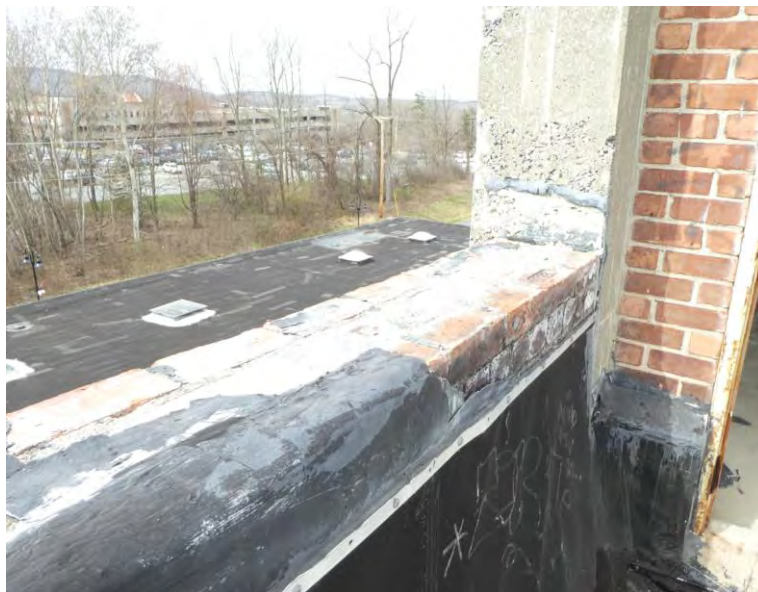
- Along the west side of Building 1, an approximately 10-foot-long section of parapet coping stone has fallen off the roof and onto a lower corrugated roof deck and open web metal joist system. This has caused local failure of both the roof deck and the metal joists. Based on the dimensions and weight of the stone, this was likely caused by human intervention (vandalism). A similar instance was observed at the next adjacent coping stone, which is at risk of falling onto the lower structure.

*Photo 44: Building 1, west wall missing roof parapet coping stone.*

- 1.1.6 All masonry parapets are in poor condition and should be repointed and damaged bricks be replaced. All damaged or missing coping stones along with their respective through wall flashings should be re-built or replaced. **The coping stones on the west wall of Building 1 are loose and are in danger of falling onto a lower roof. These should be re-set as soon as possible.**

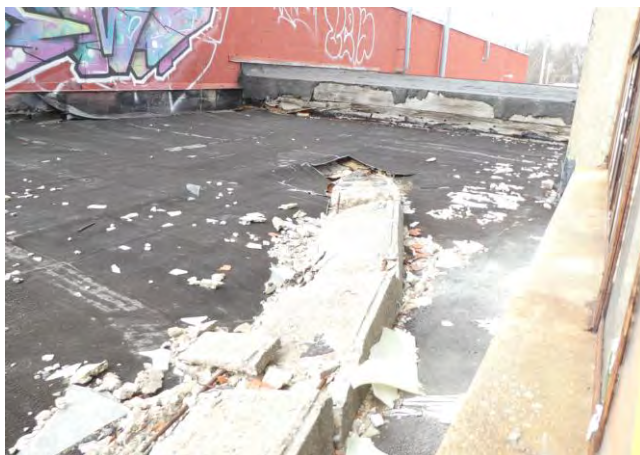
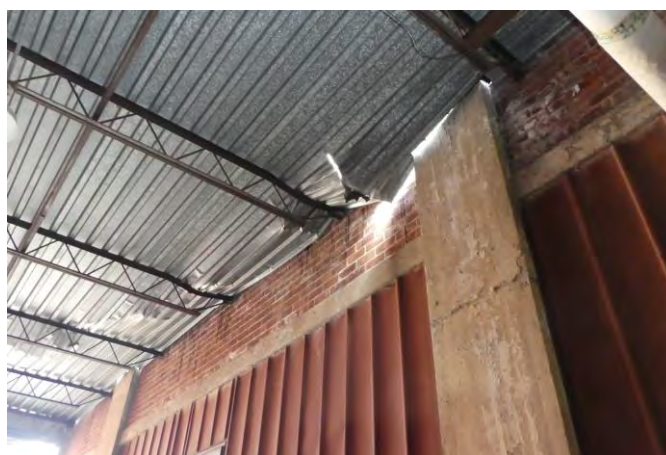
*Photos 45 and 46: Lower roof west of Building 1, images of fallen coping stone and structural damage to roof deck and joists.*

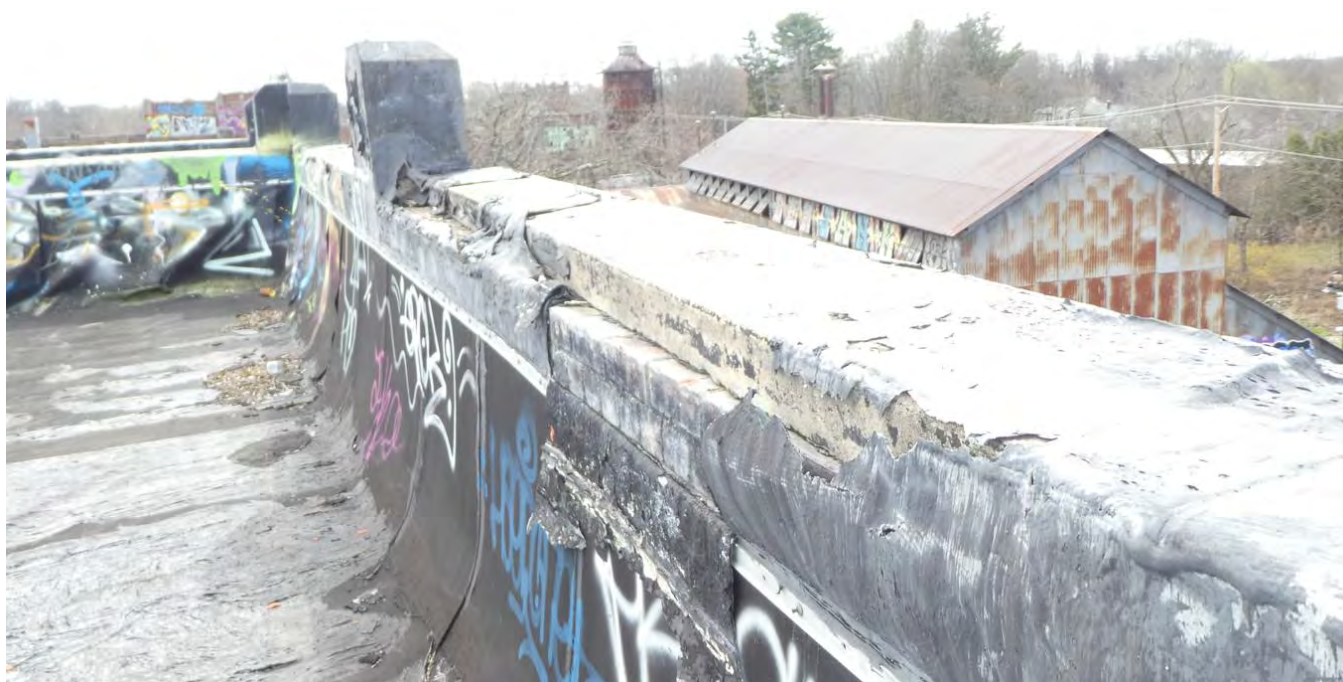
*Photo 47: Building 1, west wall; coping stone at risk of falling onto lower roof.*

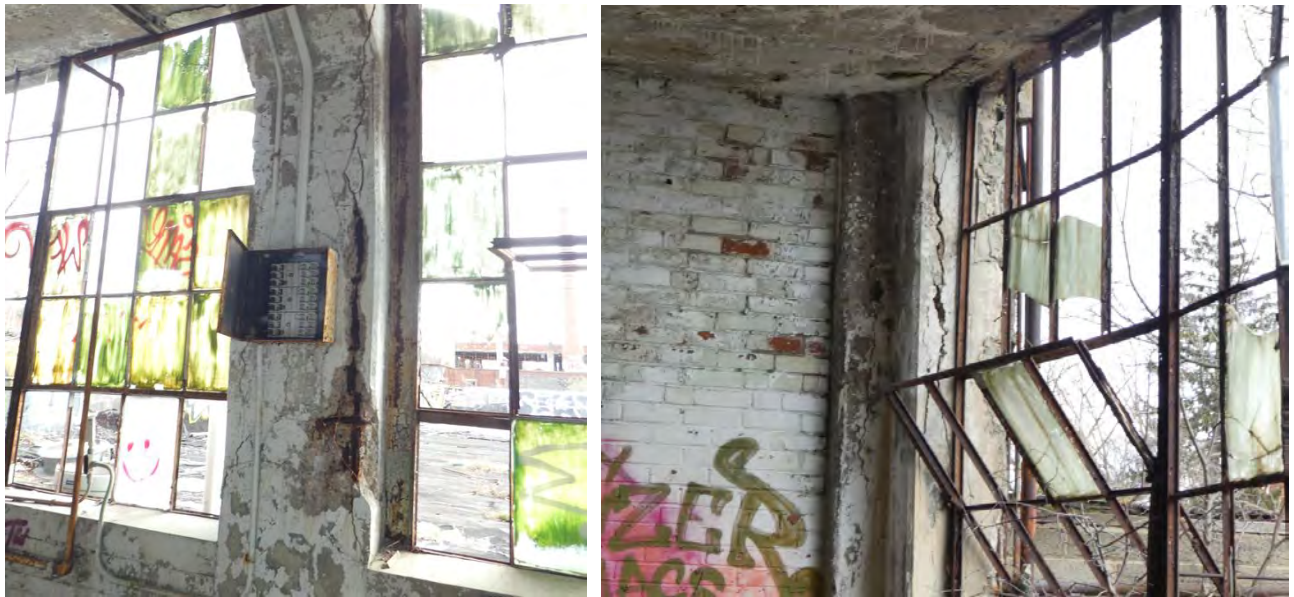
- On the second floor of Building 1, several exterior concrete columns have exposed reinforcing bar and large vertical and diagonal cracks indicative of spalling caused by the corrosion of steel reinforcing.

*Photos 50 and 51: Building 1, cracks and exposed reinforcing in exterior concrete columns.*

- 1.1.10 The concrete columns at Building 1 have condition varying in poor to good condition. Any columns that have crack widths exceeding 1/16 inches should be sounded to determine if the concrete has delaminated from the column. Concrete in the delaminated areas should be removed and re-poured. While this is occurring, the rebar in the cracked areas should also be inspected for rust and rust should be removed prior to pouring patching concrete. Any rebar that has lost more than 15% of its section should be removed and a new bar should be spliced to the existing.

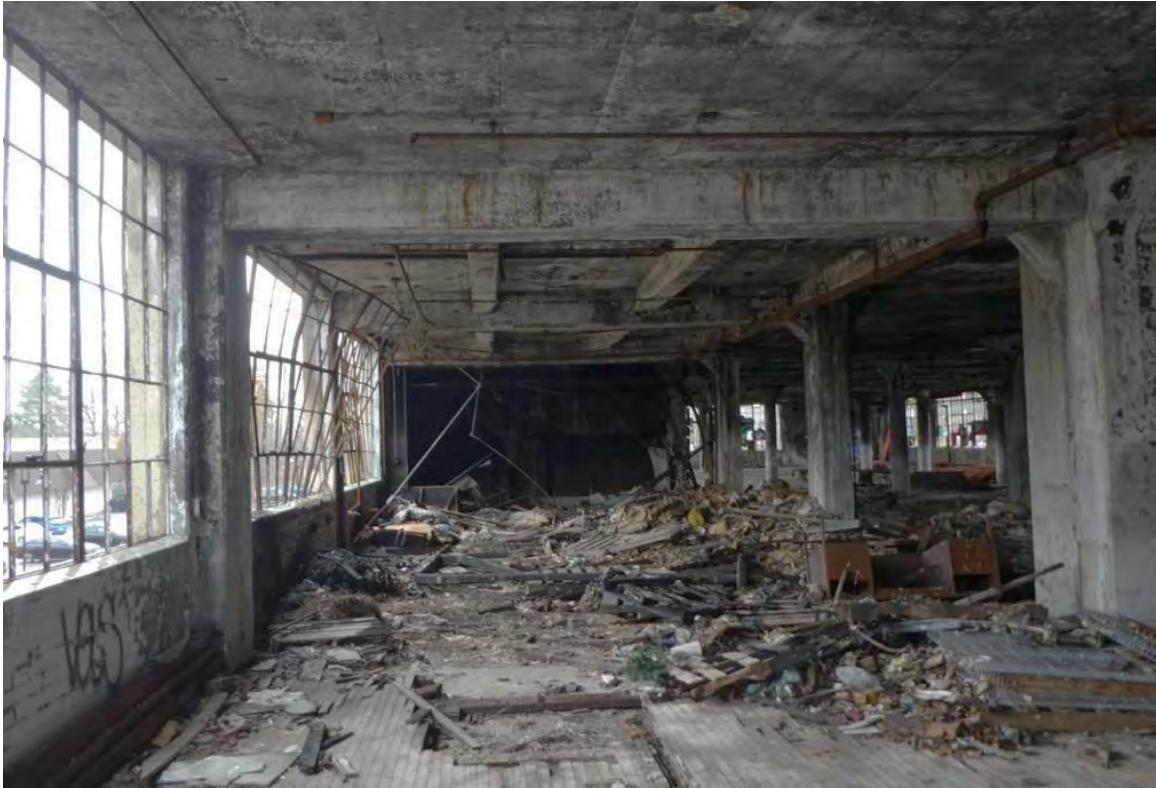
- Soot and smoke staining on concrete structural elements (slab, beams, columns) were observed on the third floor of Building 10 and on the second floor of Buildings 12 through 14. Additionally, burnt debris was observed throughout the area. Concrete beams and slab components exhibit varying degrees of cracking and spalling, specifically along building 14 concrete beams (see photo 55).

*Photos 55 (above): Building 14 second floor, staining from fire damage (looking north) and Photo 56 (below): Building 12 second floor, staining from fire damage (looking north).*

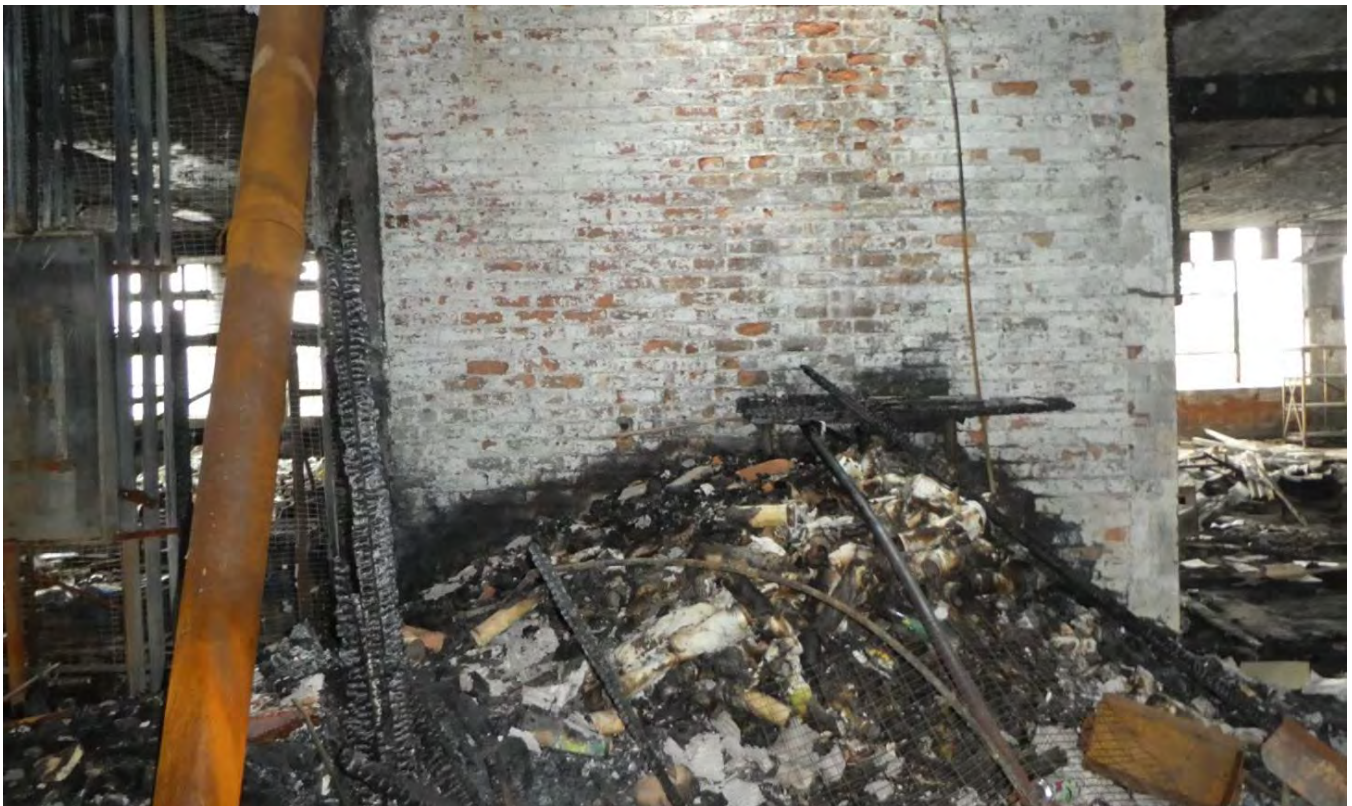
*Photos 57 (above): Building 10 third floor, staining from fire damage (looking northeast) and Photo 58 (below): Building 10 third floor, building debris from fire at freight elevator (looking north).*

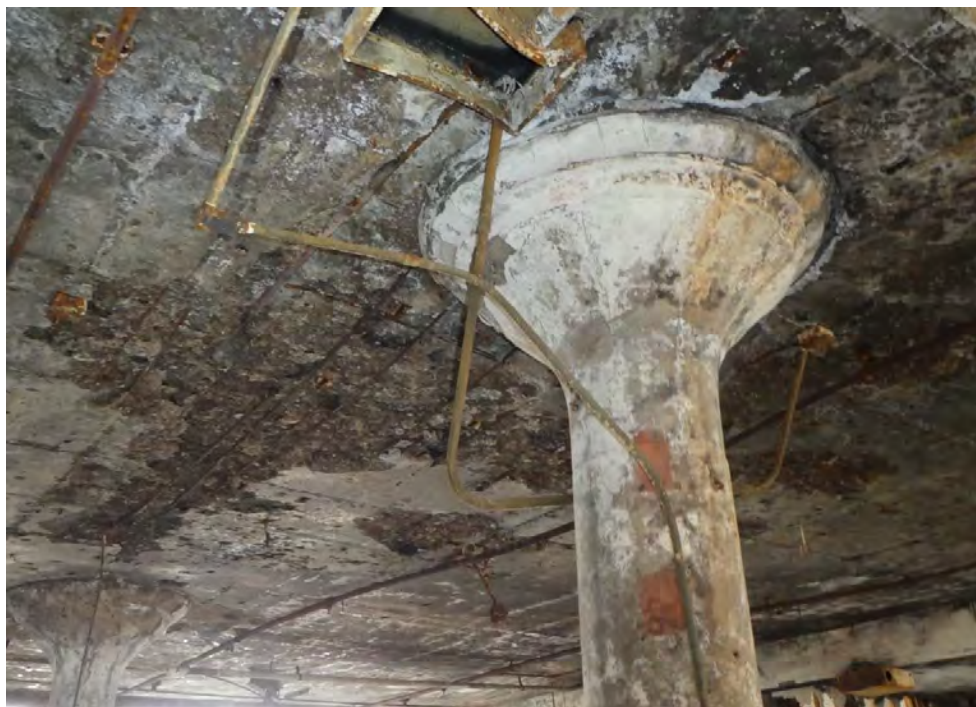
- Stored materials, such as storage rack components, textiles, and other raw materials are stored in various areas of the building leading to impassible conditions. On the third floor of Building 12, the concentrated storage of materials is causing floor sagging and spalling of the concrete, as observed from the ceiling of the second floor.

*Photos 59 (above): Building 12 third floor, concentrated stored materials (looking southwest) and Photo 60 (below): Building 12 second floor looking at third floor bottom of slab, spalling, exposed rebar and sagging of slab under stored materials (looking southeast).*

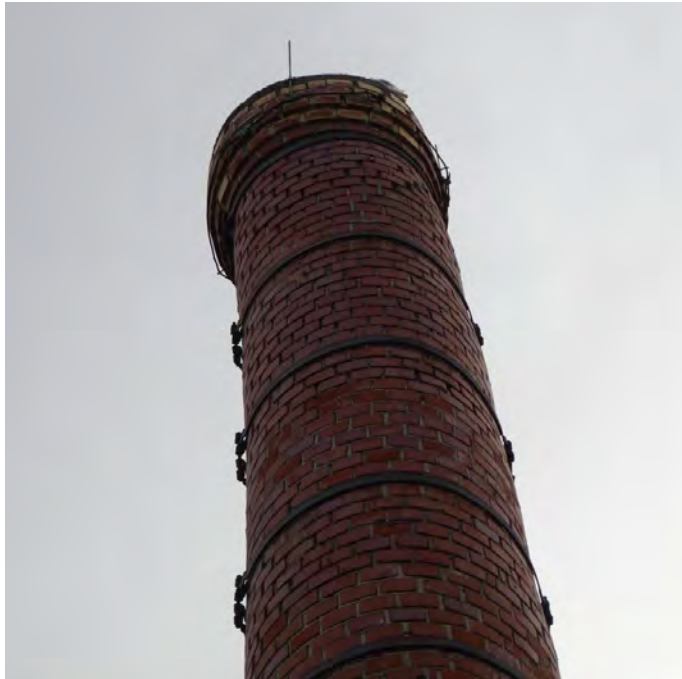
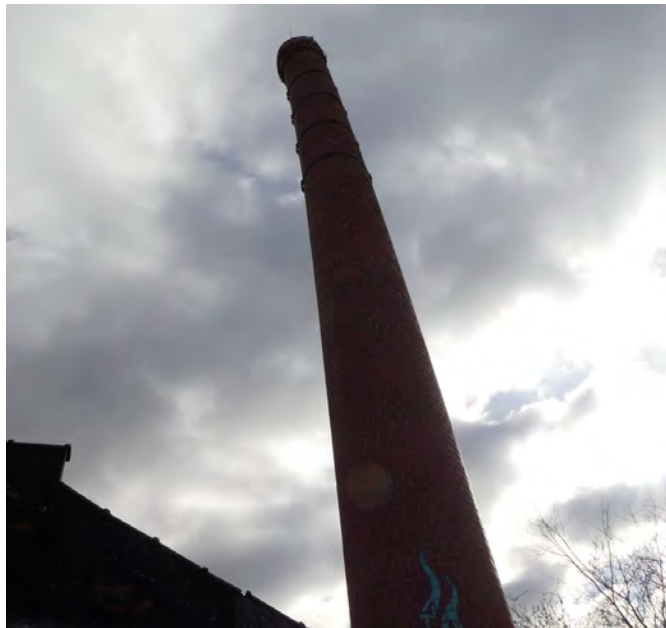
- The 74-foot-tall brick boiler flue stack is leaning to the north approximately 0.72 degrees, or approximately 11.25 inches. This may be under or overconservative and should be verified using a surveyor. Additionally, the head and bed joints along the upper third of the stack are severely deteriorated.
- The 98-foot-tall brick boiler flue stack is leaning to the north approximately 0.43 degrees, or approximately 8.75 inches. This may be under or overconservative and should be verified using a surveyor. Additionally, the head and bed joints along the upper third of the stack are severely deteriorated.

*Photos 63 and 64: 74-foot-tall Boiler stack*
