## **APPENDIX C.5 | SOUTH BUILDING FIELD NOTES**

SCHATZ BOA  
60 FAIRLAWN AVE  
POUGHKEEPSIE, NY

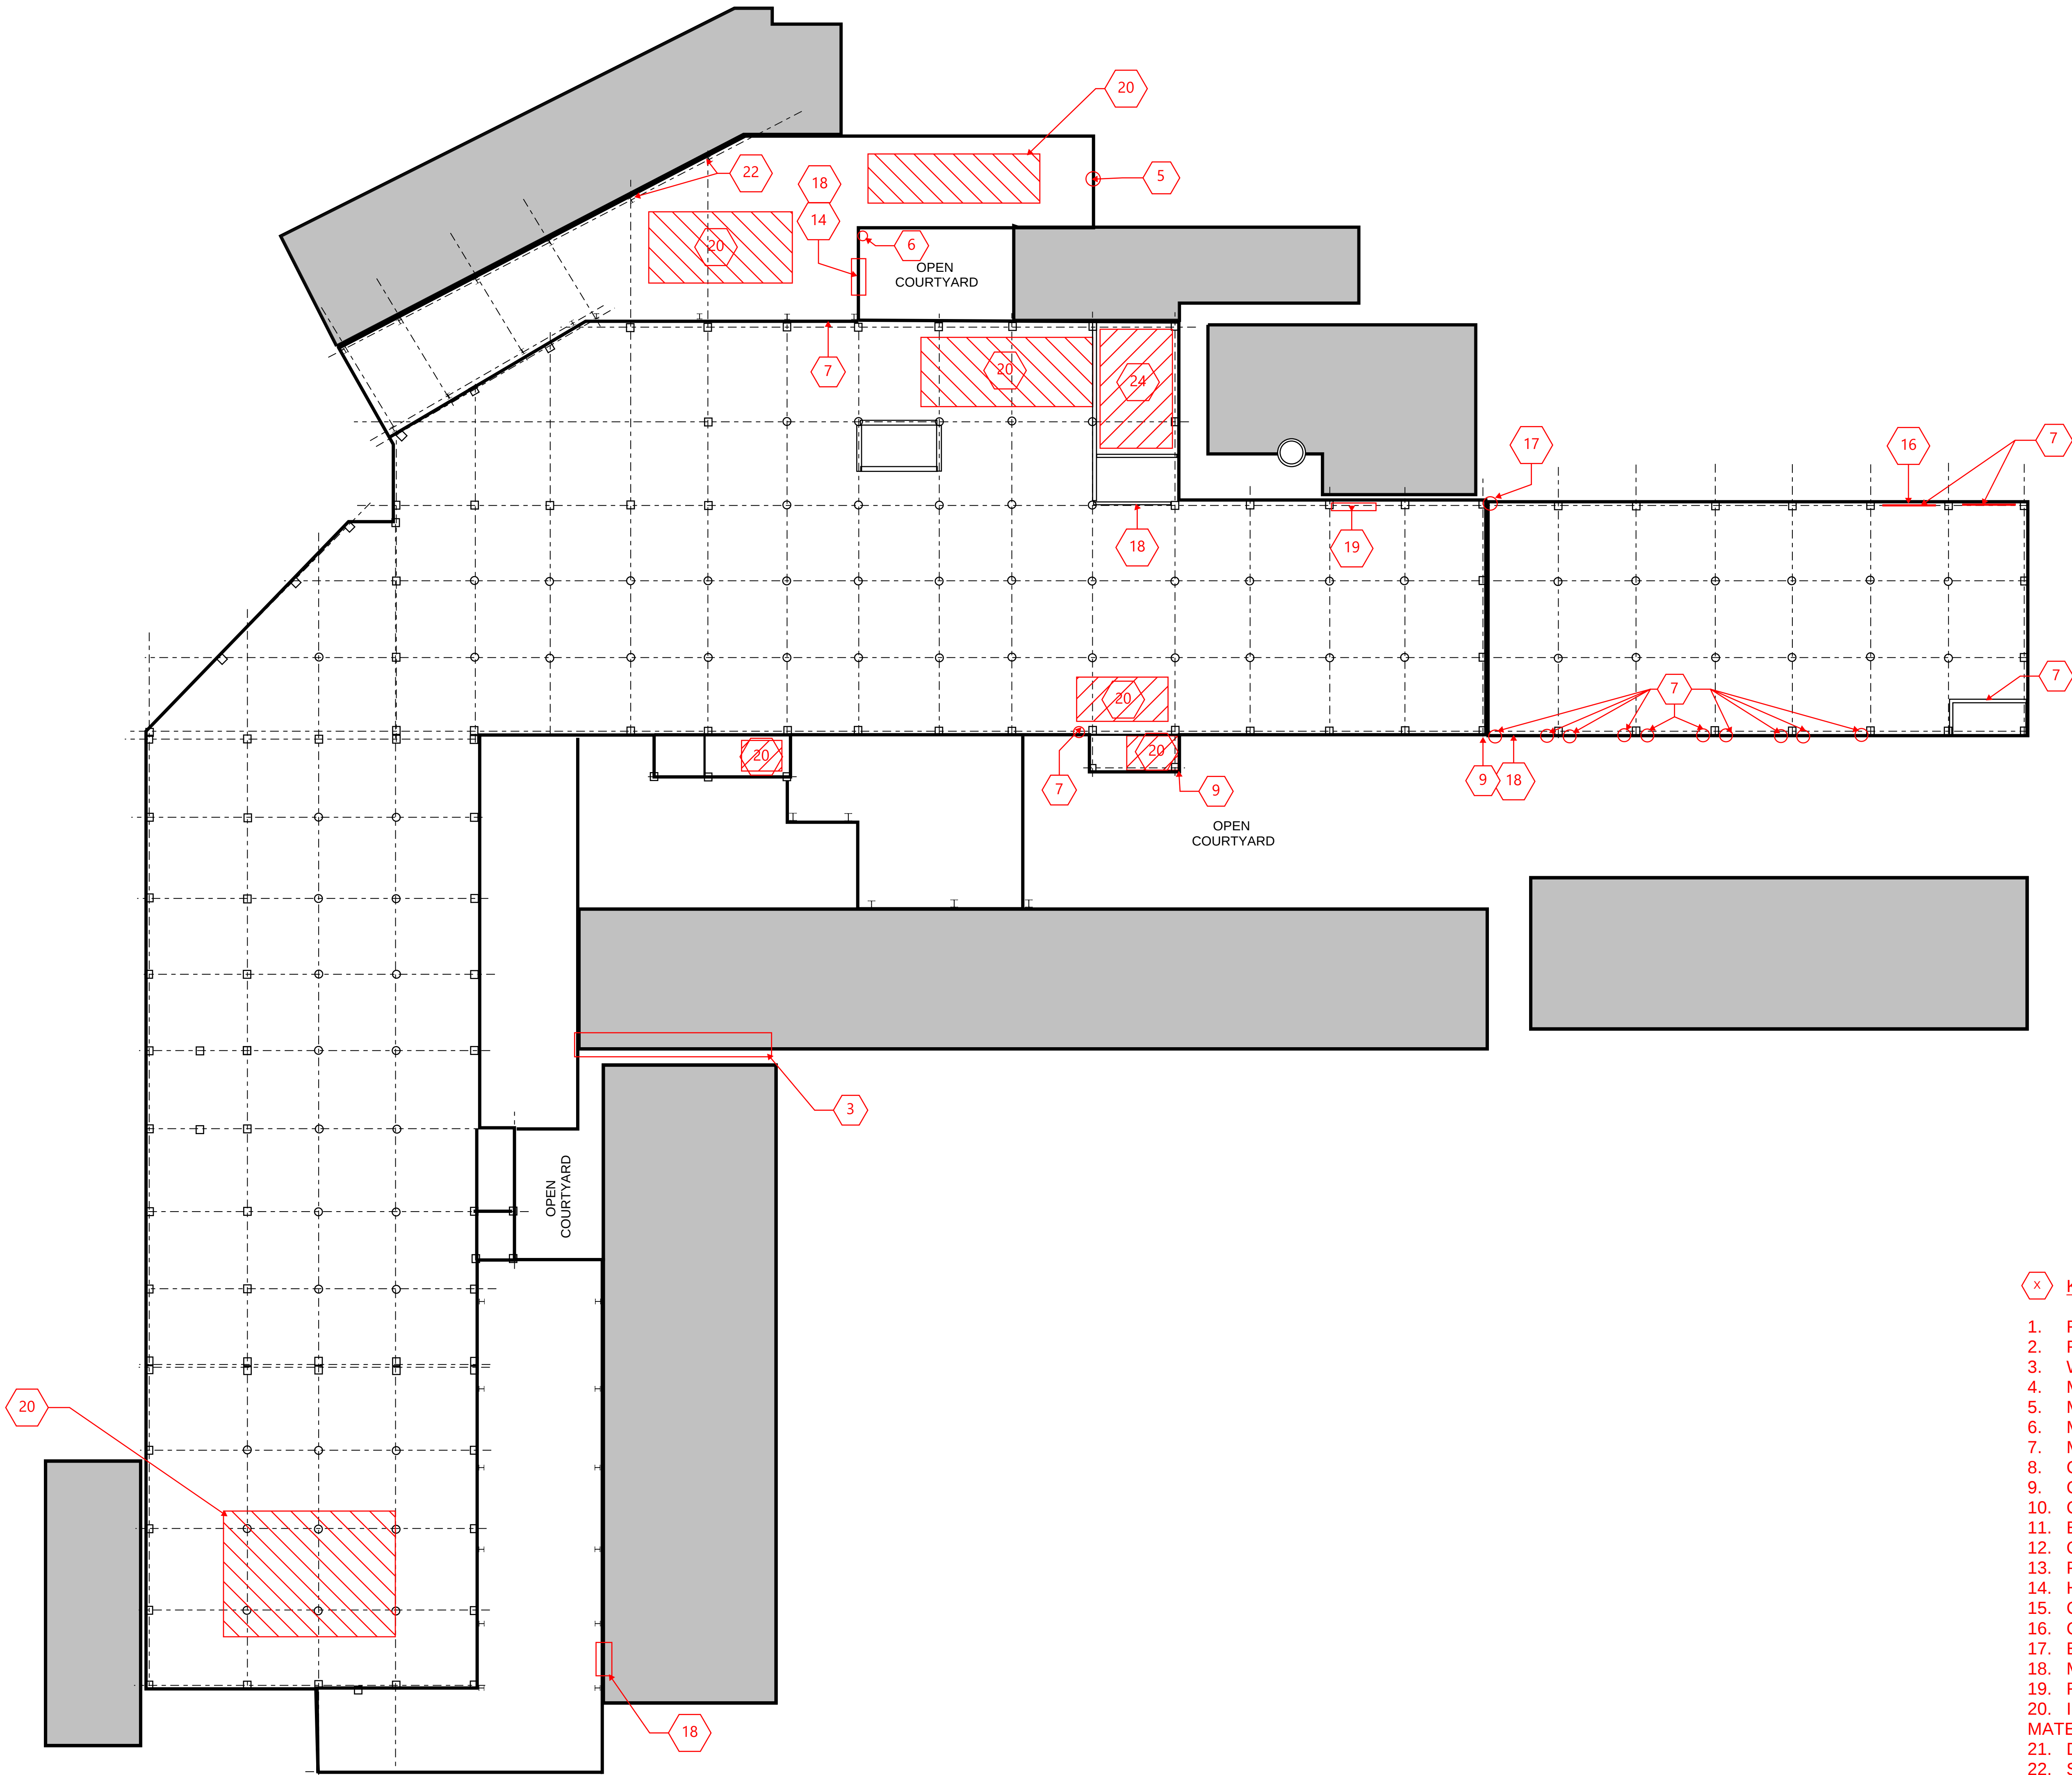
GROUND FLOOR PLAN  
SOUTH BUILDING

- KEYNOTES:**
- 1. FLOOR COLLAPSE
  - 2. ROOF COLLAPSE
  - 3. WALL COLLAPSE
  - 4. MASONRY DETERIORATION
  - 5. MASONRY CRACKS (HORIZONTAL)
  - 6. MASONRY CRACKS (VERTICAL)
  - 7. MASONRY CRACKS (DIAGONAL)
  - 8. CONCRETE FLOOR SLAB CRACKS/SPALLS
  - 9. CONCRETE COLUMN CRACKING/SPALLING
  - 10. CONCRETE BEAM CRACKING/SPALLING
  - 11. EXPOSED REBAR
  - 12. ORGANIC GROWTH ON STRUCTURAL ELEMENT
  - 13. PARAPET DAMAGE
  - 14. HEADER/LINTEL DAMAGE
  - 15. CMU WALL DAMAGE
  - 16. CRUMBLED BRICK FRAGMENTS
  - 17. EFFLORESCENCE
  - 18. MISSING MASONRY UNITS (BRICK OR CMU)
  - 19. FOUNDATION DETERIORATION
  - 20. INACCESSIBLE AREAS (DEBRIS OR EXCESSIVE MATERIAL STORAGE)
  - 21. DETERIORATED GYPSUM/CONC ROOF DECK
  - 22. STEEL COLUMN DAMAGE/DETERIORATION
  - 23. DAMAGED STEEL BEAM OR METAL JOIST
  - 24. BLACK MOLD

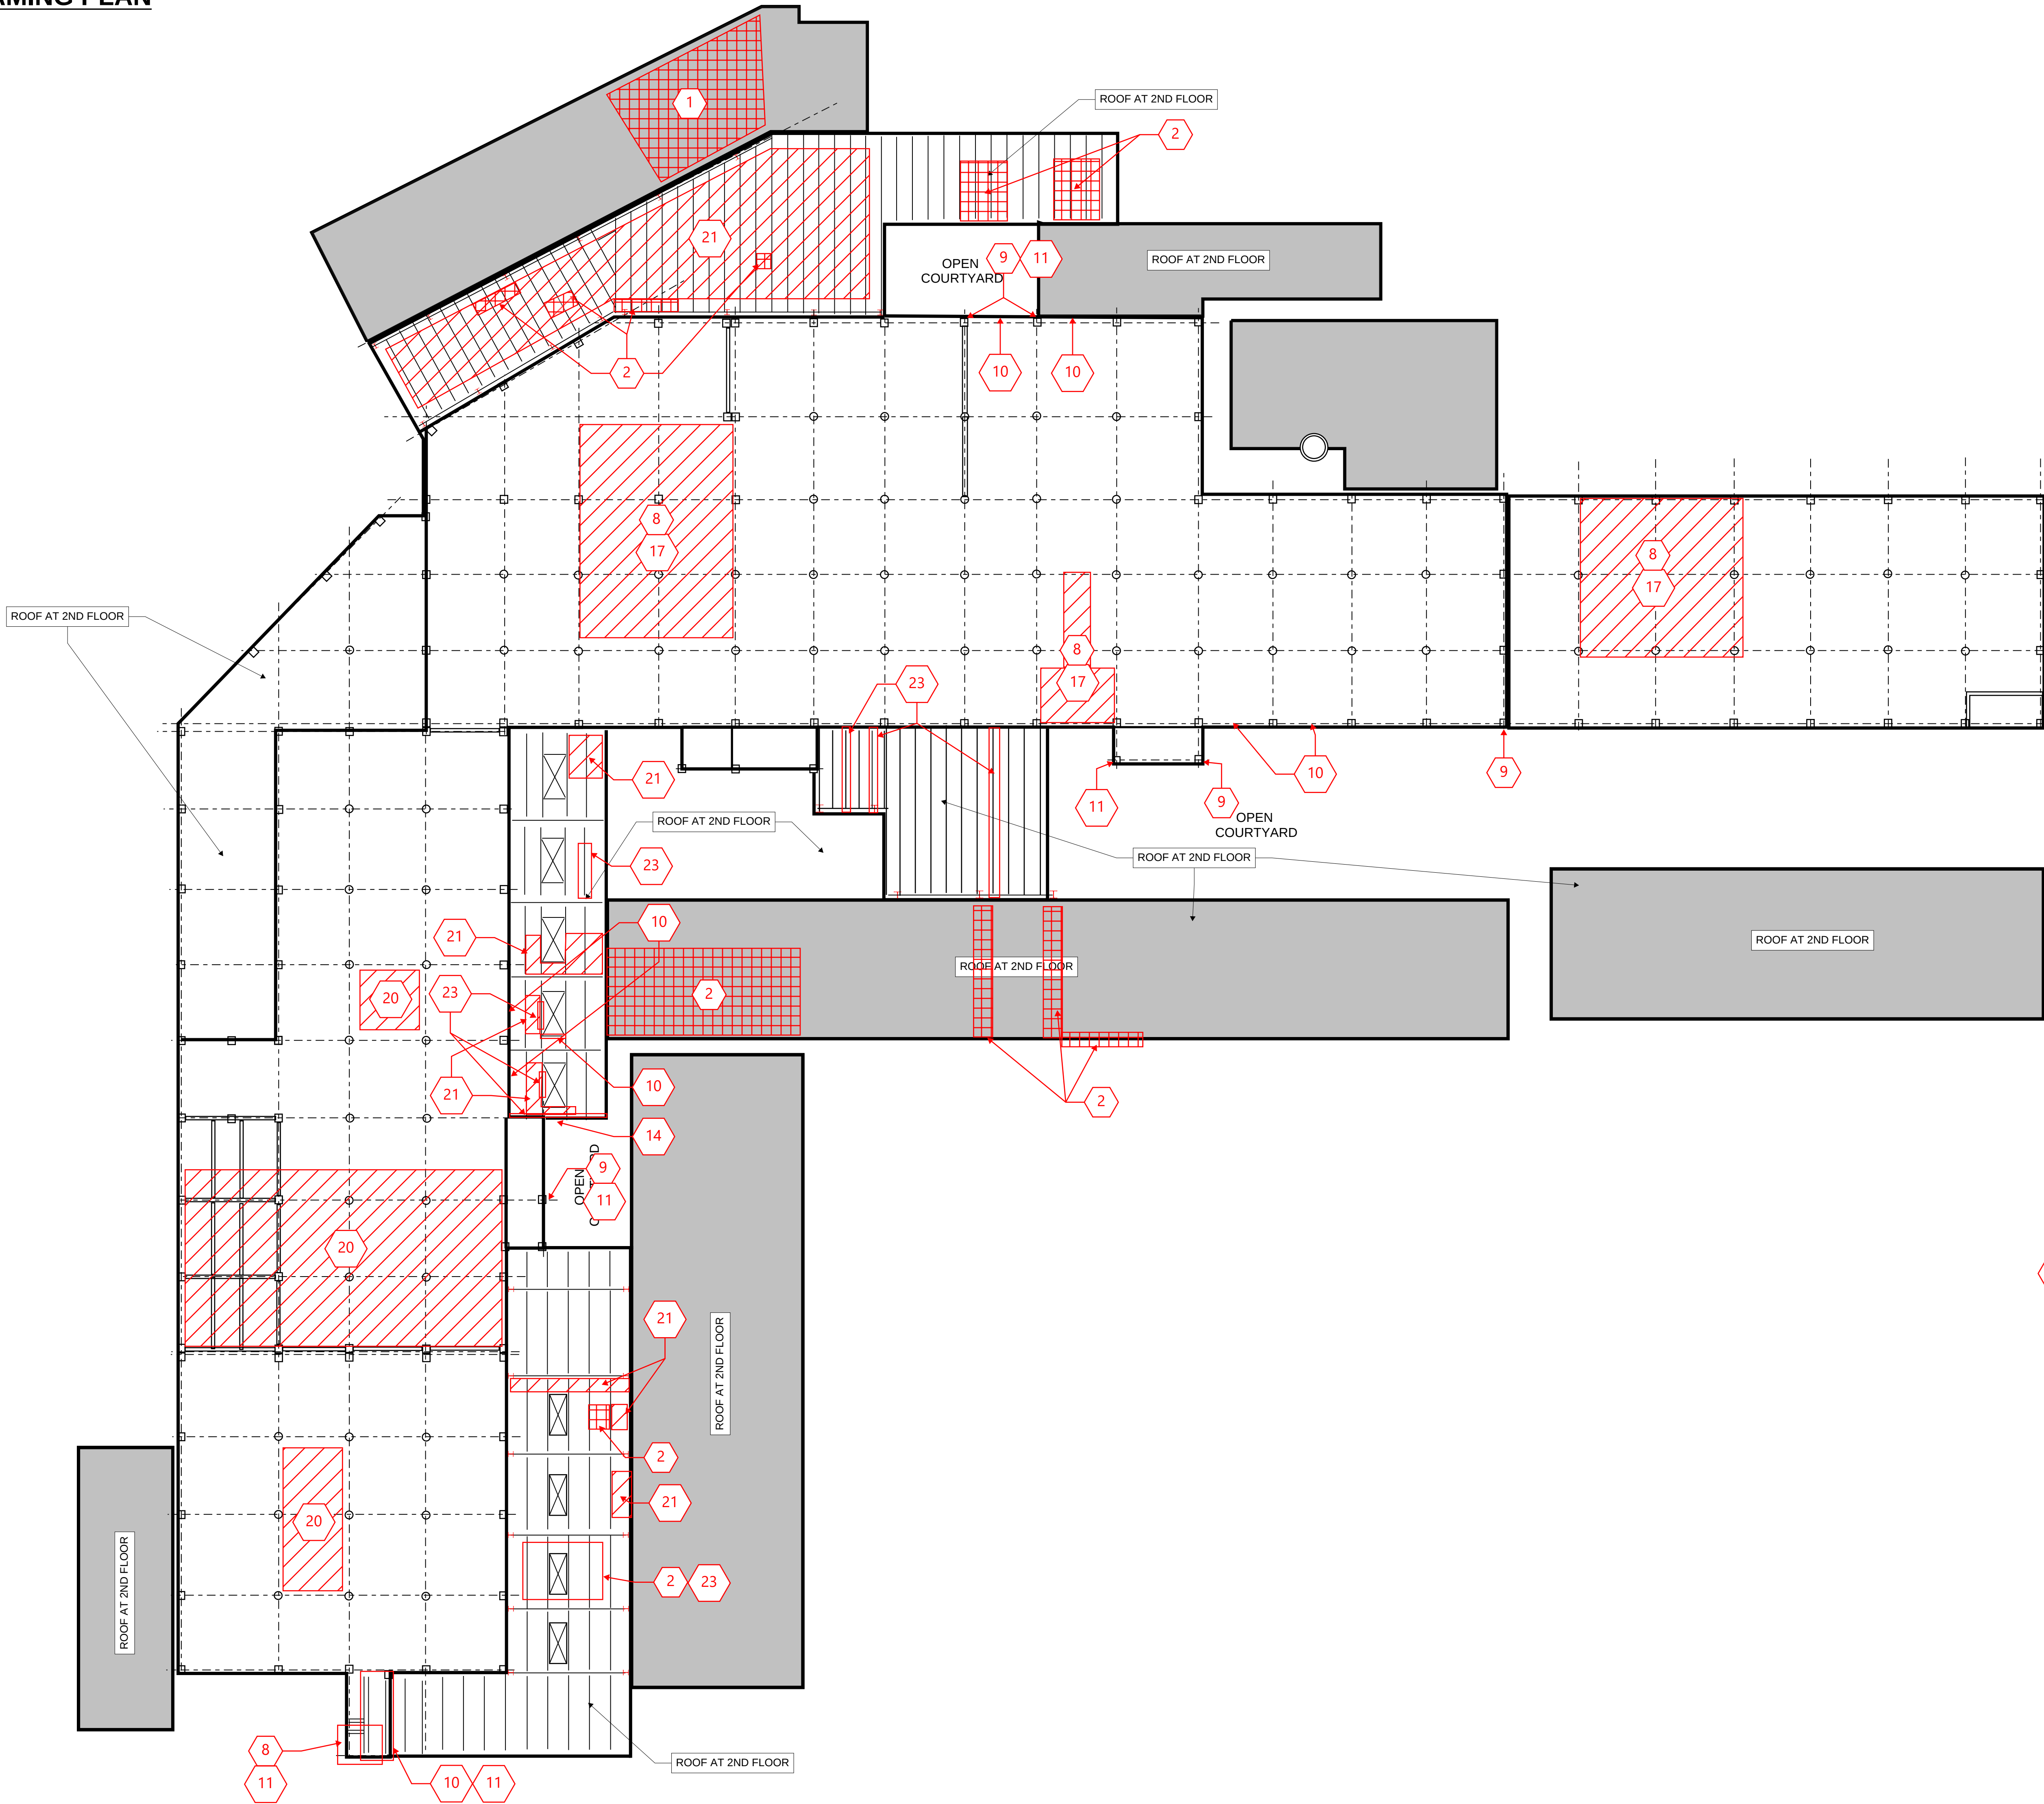
SECOND FLOOR FRAMING PLAN  
SOUTH BUILDING

- KEYNOTES:**
- 1. FLOOR COLLAPSE
  - 2. ROOF COLLAPSE
  - 3. WALL COLLAPSE
  - 4. MASONRY DETERIORATION
  - 5. MASONRY CRACKS (HORIZONTAL)
  - 6. MASONRY CRACKS (VERTICAL)
  - 7. MASONRY CRACKS (DIAGONAL)
  - 8. CONCRETE FLOOR SLAB CRACKS/SPALLS
  - 9. CONCRETE COLUMN CRACKING/SPALLING
  - 10. CONCRETE BEAM CRACKING/SPALLING
  - 11. EXPOSED REBAR
  - 12. ORGANIC GROWTH ON STRUCTURAL ELEMENT
  - 13. PARAPET DAMAGE
  - 14. HEADER/LINTEL DAMAGE
  - 15. CMU WALL DAMAGE
  - 16. CRUMBLED BRICK FRAGMENTS
  - 17. EFFLORESCENCE
  - 18. MISSING MASONRY UNITS (BRICK OR CMU)
  - 19. FOUNDATION DETERIORATION
  - 20. INACCESSIBLE AREAS (DEBRIS OR EXCESSIVE MATERIAL STORAGE)
  - 21. DETERIORATED GYPSUM/CONC ROOF DECK
  - 22. STEEL COLUMN DAMAGE/DETERIORATION
  - 23. DAMAGED STEEL BEAM OR METAL JOIST
  - 24. BLACK MOLD
