# Structural Condition Assessment

## Former Schatz Manufacturing Co. Building Campus

Fairview Avenue, Poughkeepsie NY

Date: June 28th, 2024

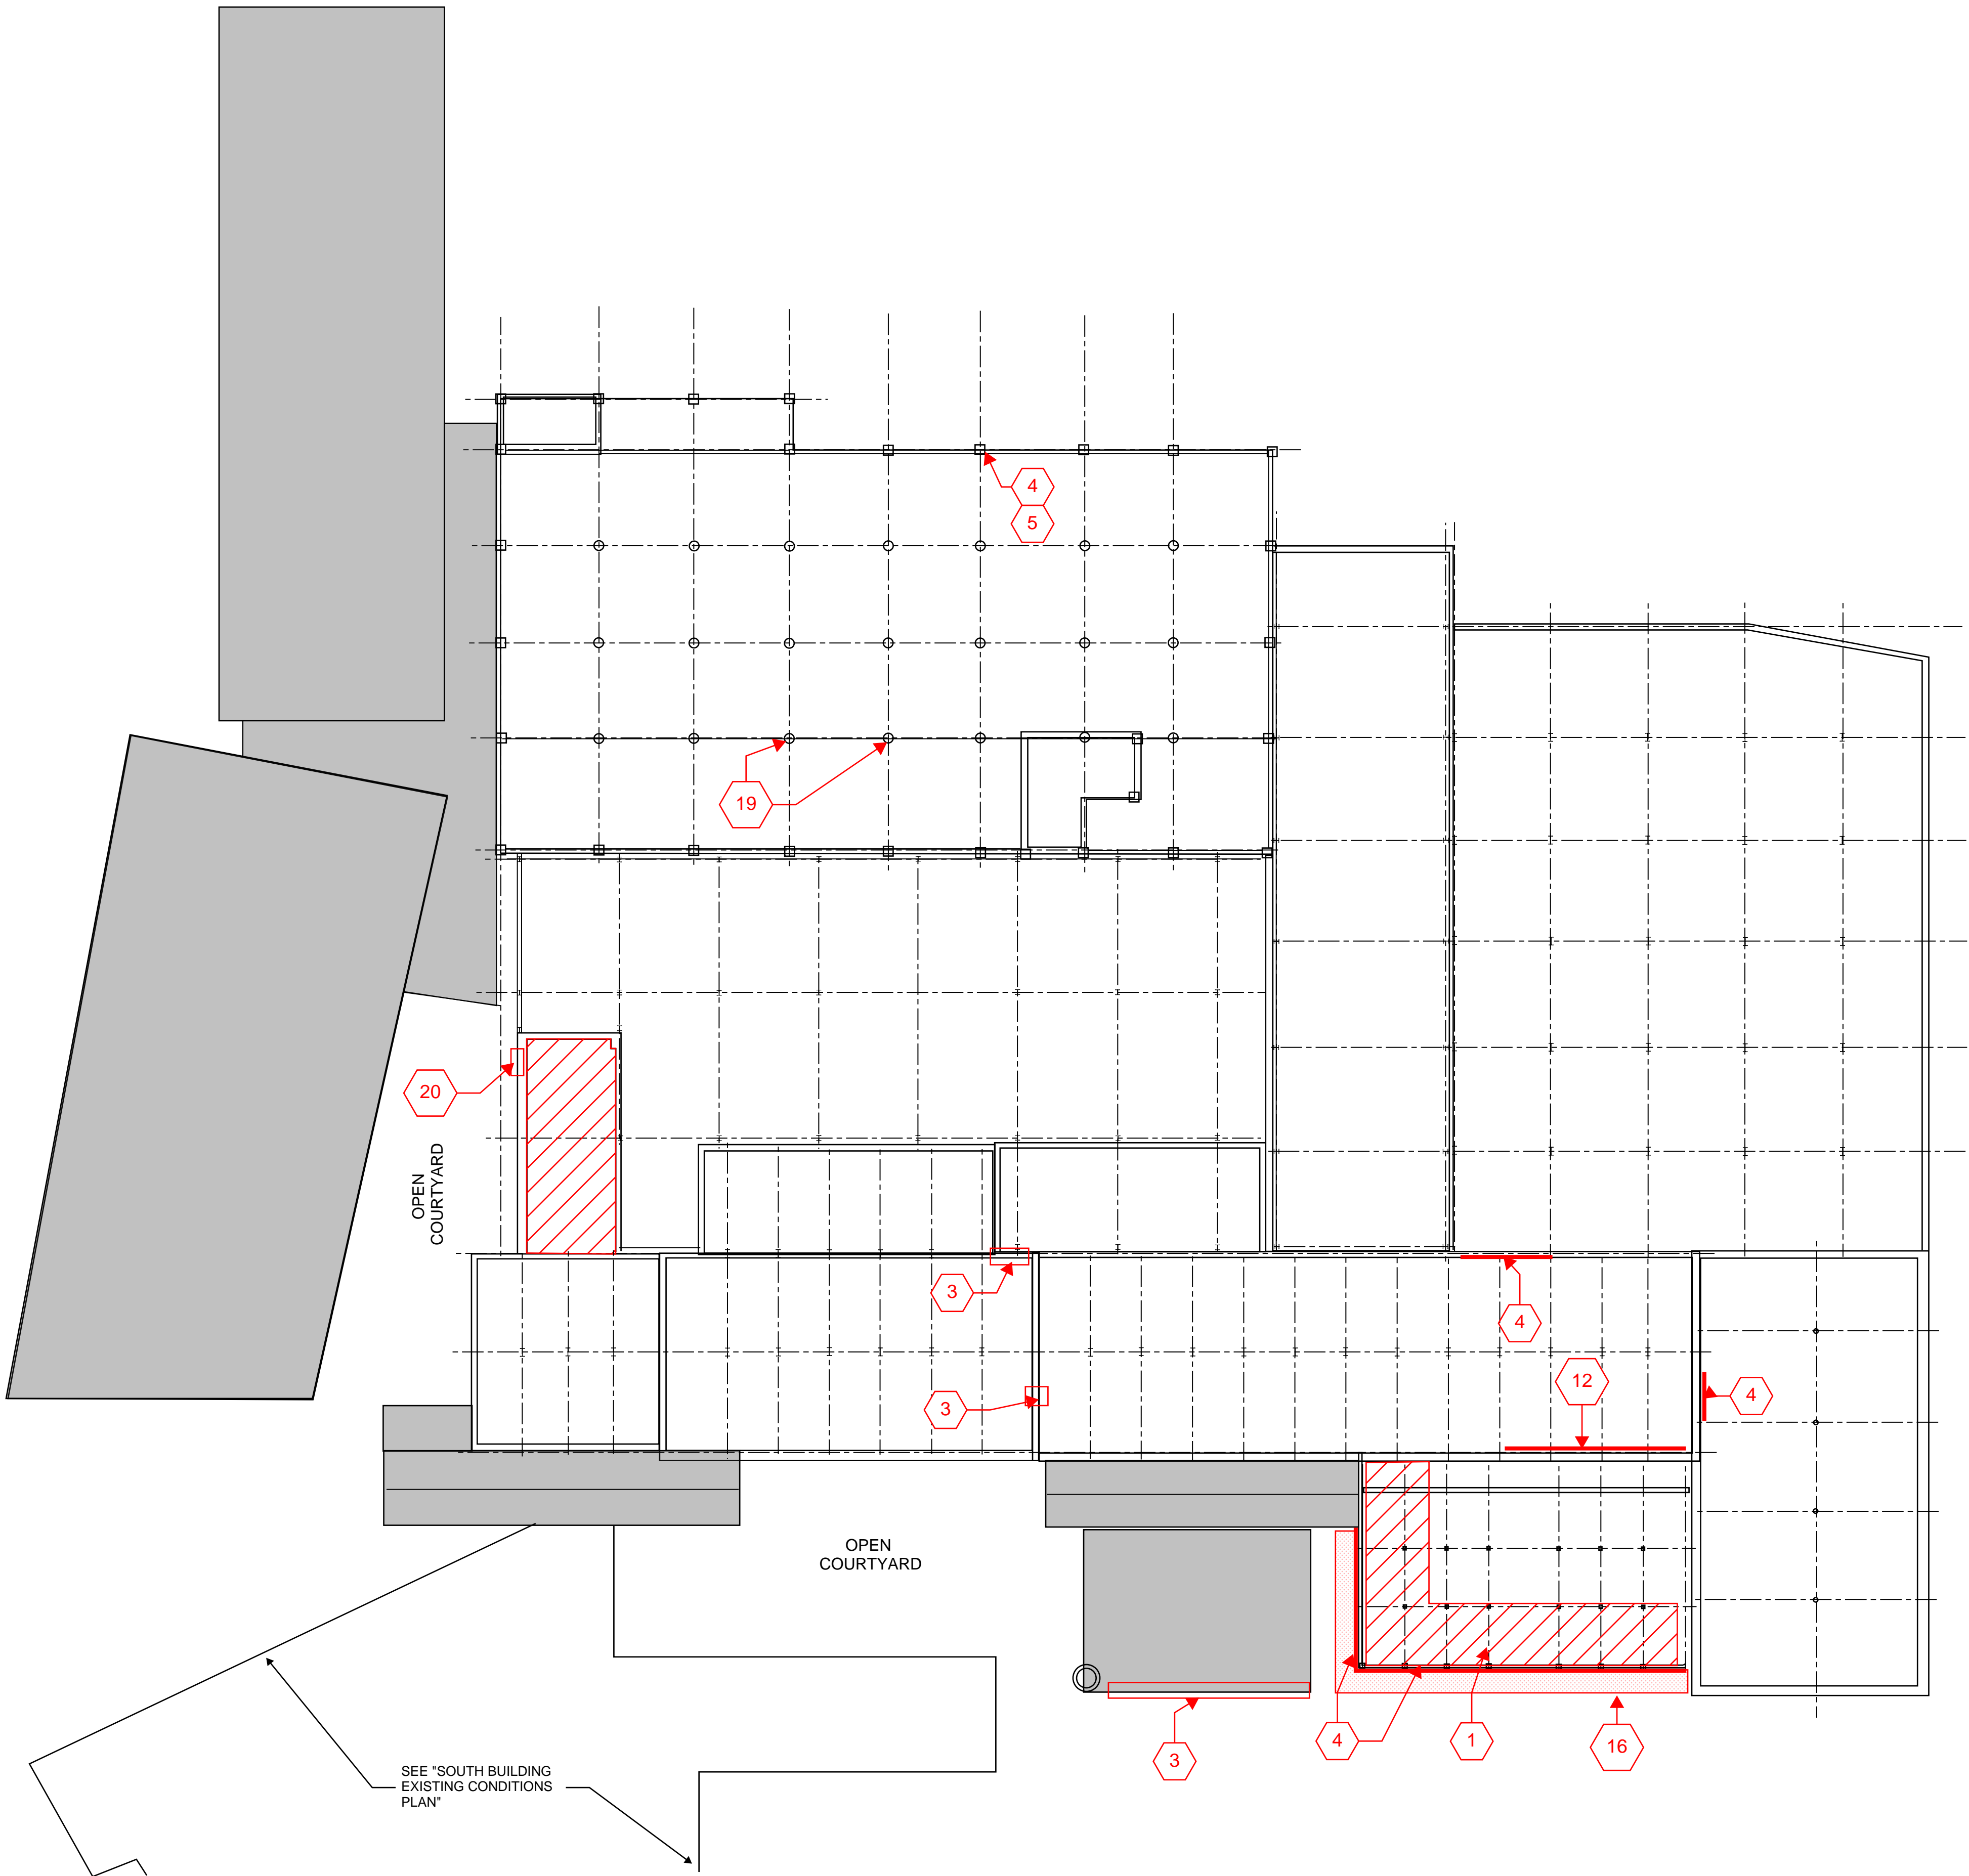
GROUND FLOOR PLAN  
NORTH BUILDING

- KEYNOTES:**
- 1. FLOOR COLLAPSE
  - 2. ROOF COLLAPSE
  - 3. WALL COLLAPSE
  - 4. MASONRY DETERIORATION
  - 5. MASONRY CRACKS (HORIZONTAL)
  - 6. MASONRY CRACKS (VERTICAL)
  - 7. MASONRY CRACKS (DIAGONAL)
  - 8. CONCRETE FLOOR SLAB CRACKS/SPALLS
  - 9. CONCRETE COLUMN CRACKING/SPALLING
  - 10. CONCRETE BEAM CRACKING/SPALLING
  - 11. EXPOSED REBAR
  - 12. ORGANIC GROWTH ON STRUCTURAL ELEMENT
  - 13. PARAPET DAMAGE
  - 14. HEADER/LINTEL DAMAGE
  - 15. CMU WALL DAMAGE
  - 16. CRUMBLLED BRICK FRAGMENTS
  - 17. EFFLORESCENCE
  - 18. MISSING MASONRY UNITS (BRICK OR CMU)
  - 19. FOUNDATION DETERIORATION
  - 20. INACCESSIBLE AREAS (DEBRIS OR EXCESSIVE MATERIAL STORAGE)
  - 21. DETERIORATED GYPSUM/CONC ROOF DECK
  - 22. STEEL COLUMN DAMAGE/DETERIORATION
  - 23. DAMAGED STEEL BEAM OR METAL JOIST
  - 24. BLACK MOLD
