## APPENDIX D.

## ENVIRONMENTAL SITE PROFILES

## **Unoccupied Industrial Buildings**

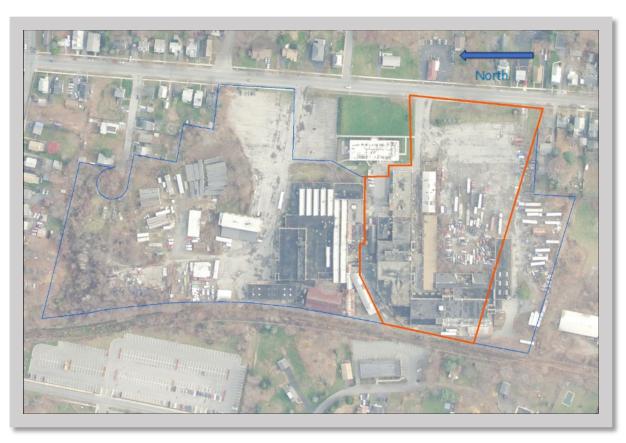
**Environmental Background:** This property has been utilized for industrial purposes since the early 1930s and is located adjacent to a former railroad (N.Y.N.H. & H.R.R. (Hospital Branch)). A railroad spur is located on the northern portion of the parcel. Several underground storage tanks (USTs) have been identified on the north and northeastern portions of parcel, north of the factory building. There are no records of

tank removals and orphan tanks may be present. Four abandoned above ground storage tanks (ASTs) have been identified in the former coal building. In 1990, 370-gallons of #6 oil was spilled due to a broken heater pipe that has reportedly been remediated. Several trailers, vehicles, and junk cars have been staged adjacent to the southwestern

portion of the building which may be leaking automotive fluids. Several drums of petroleum, paints, solvents, and dyes were located within the building and reportedly removed in 2008. Sampling in 1993 and 2019-2020 has identified polychlorinated biphenyls (PCBs) and lead based paint in the walls and floors of the buildings. Regulated building materials are also likely to be present based on the age of construction. Sampling has determined that PCBs have penetrated masonry and wood building components.

Recommendations: Further evaluation of the property is recommended to verify the presence of orphan tanks and assess the nature and extent of subsurface and groundwater impacts. Removal and/or remediation of orphan tanks, impacted soil and/or groundwater should be completed. Miscellaneous items and regulated materials on the property should be removed prior to evaluation of subsurface conditions. Masonry, wood, and other materials located within site buildings that may contain PCBs and/or regulated building materials will require assessment and mitigation as part of planned redevelopment efforts.

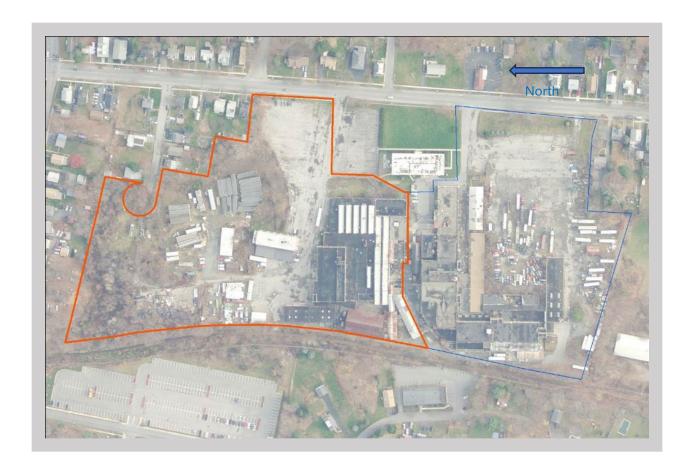
indicate that the southern portion of this parcel was first developed in the late 1910s as the original Schatz Manufacturing building, identified as the "North Factory". In the late 1930s, two (2) buildings were constructed on either side of the factory building utilized as a heat treatment building on the southwestern portion and a rehab building on the eastern portion. An addition to the north of the original factory building is visible on the 1940 aerial photograph as well as a baseball field on the northern portion of the parcel. Between the 1940s-1970s, the central building, heat treatment building on the western portion as well as a storage building, and north factory annex were constructed. Between the 1970s-mid 1990s, the baseball fields appear to less utilized and former dwellings located on the northwestern portion of the parcel appear to have been demolished.

**Environmental Background:** The property has been utilized for industrial uses since the early 1900s and is located adjacent to a former railroad (N.Y.N.H. & H.R.R. (Hospital Branch)). A railroad spur is located on the southern portion of this parcel, south of the "North Factory" building. Several underground storage tanks (USTs) appear to have been located on the eastern portion of this parcel. It is possible that orphan tanks may remain on this property. An

inspection conducted by the NYSDEC in 1986 identified several drums, electrical capacitors, and quenching pits that contained oil. Forty-five (45) drums were observed to contain hazardous waste and were removed from the property. Sampling of the buildings in 1987 and 2019-2020 has identified polychlorinated biphenyls (PCBs) in the flooring and other surfaces within the buildings. Regulated building materials are also likely to be present based on the age of construction. Subsurface investigations have identified soil and groundwater containing elevated levels of volatile and semi-volatile organic compounds, metals, PCBs, and pesticides on the northern and southwestern portions of the parcel.

**Groundwater Conditions**: Subsurface sampling in the area of the heat treatment building on the western portion of the parcel has confirmed RCRA metals and volatile and semi-volatile organic compounds in exceedance of levels of protection of groundwater and soil in residential, commercial and industrial settings.

**Recommendations:** Further evaluation of the property to determine the presence of orphan tanks and determine the nature

and extent of subsurface and groundwater impacts. Removal and/or remediation of orphan tanks and impacted soil and/or groundwater should be completed. Miscellaneous items and regulated materials on the property should be removed prior to evaluation of the subsurface. Masonry, wood, and other materials located within site buildings that may contain PCBs and/or regulated building materials will require assessment and mitigation as part of planned redevelopment efforts.

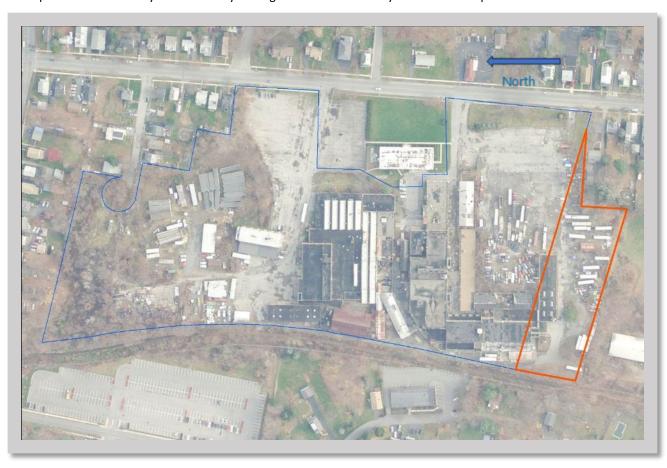
**Site History:** Review of Sanborn maps and assessment records indicate that the majority of this parcel, other than the former Schatz Manufacturing buildings, which encroach on this parcel from the north, has not been developed in the past. This parcel has been utilized for the storage of various vehicles, including trucks and trailers. The parcel was purchased in 1988 by Hudson Valley Management and in 2001 by 60 Fairview Corp.

**Environmental Background:** Several closed NYSDEC spills are listed for this property. In 1996 2,267 tons of polychlorinated biphenyl (PCB) impacted soil was reportedly removed from the southwestern portion of the parcel. Two (2) closed spills are associated with elevated pesticides and RCRA metals detected beneath a trailer leaking fluids. Active NYSDEC spill #1711338 is listed for this property (addressed as 70 Fairview Ave) and was issued during a site inspection when several drums of hydraulic oil and petroleum products were found to be leaking. Volatile organic compounds (VOCs), RCRA metals, and pesticides were identified in subsurface soils and heavy metals were identified in a groundwater sample.

**Groundwater Conditions**: RCRA metals were detected in a groundwater sample associated with Spill #1711368. Groundwater conditions have not been completely assessed for this parcel.

**Recommendations:** Further evaluation of the property to delineate the nature and extent of subsurface and groundwater impacts. Removal and/or remediation of impacted soil and groundwater is recommended. Miscellaneous items and other regulated materials on the property should be removed prior to remediation or further evaluation of the subsurface.
